**Wilmette Park District
Mallinckrodt Chimney
Masonry Repairs**

**INVITATION TO BID 2026
Mallinckrodt Chimney
Masonry Repair
WILMETTE PARK DISTRICT**

The Wilmette Park District is seeking sealed base bids for masonry repairs to the chimney that sits on 1929 Elmwood AVE Wilmette , IL 60091 located at our Mallinckrodt facility. Currently, the chimney houses Verizon Wireless telecommunications equipment.

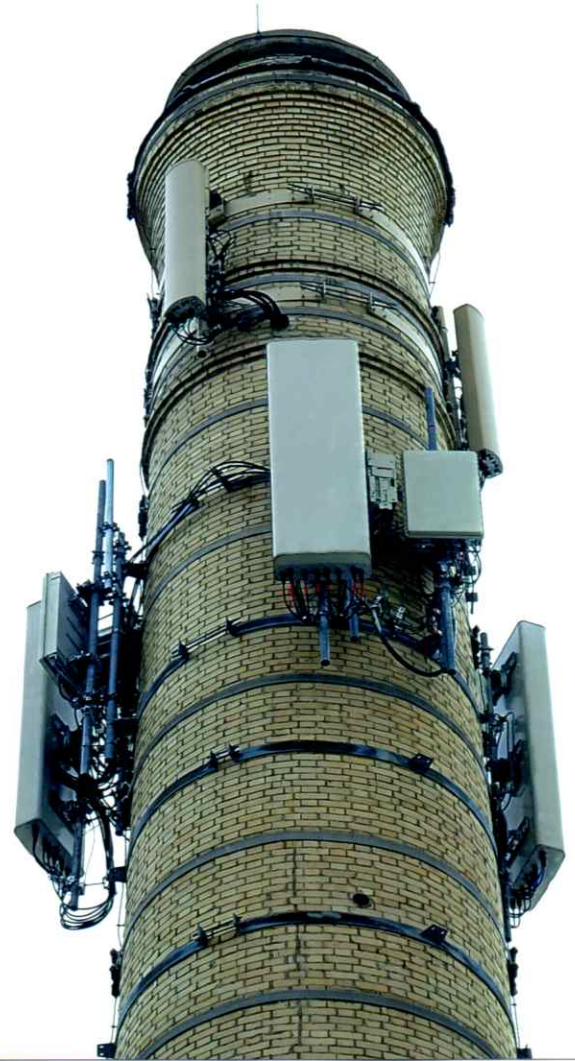
Photo 1.

Fair exterior condition of the upper elevations of the north side. Mortar joints between the 95' and 75' level were recessed and deteriorated. Thin cracks and open joints existed along previously repaired cracks. All bands and antennas were secure.

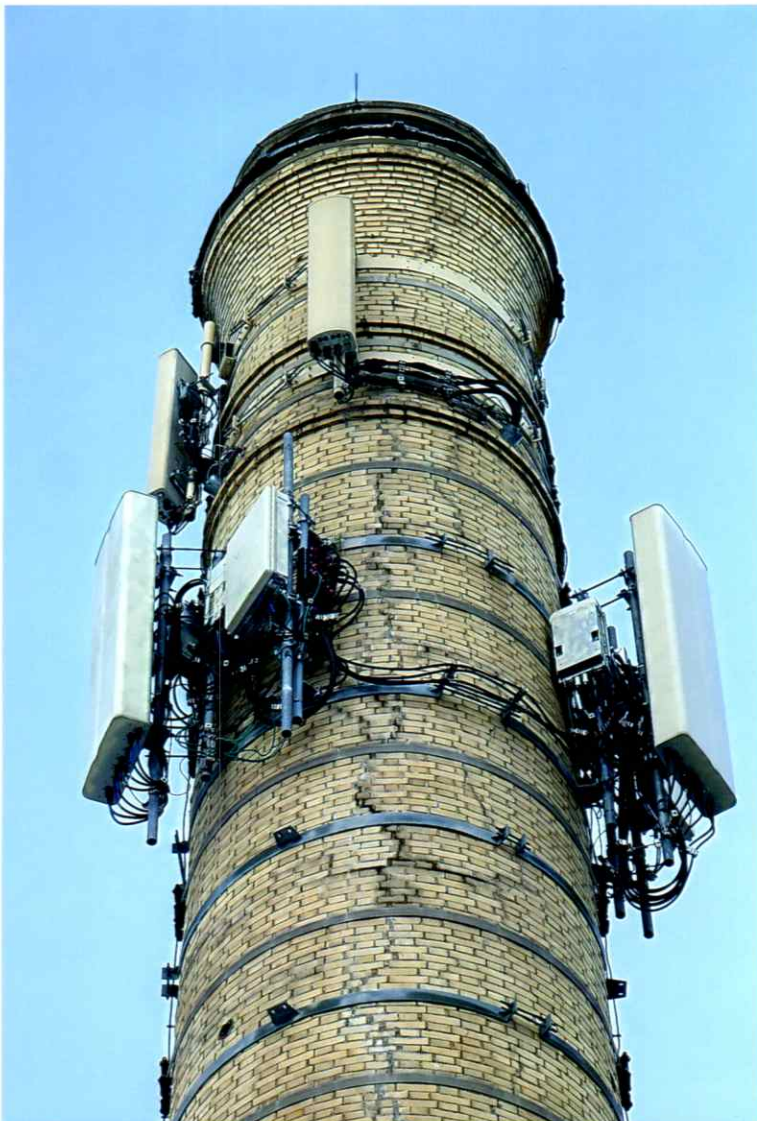
Photo 2.

Fair exterior condition of the upper elevations of the north side. Mortar joints between the 95' and 75' level were recessed and deteriorated. Thin cracks and open joints existed along previously repaired cracks. All bands and antennas were secure.

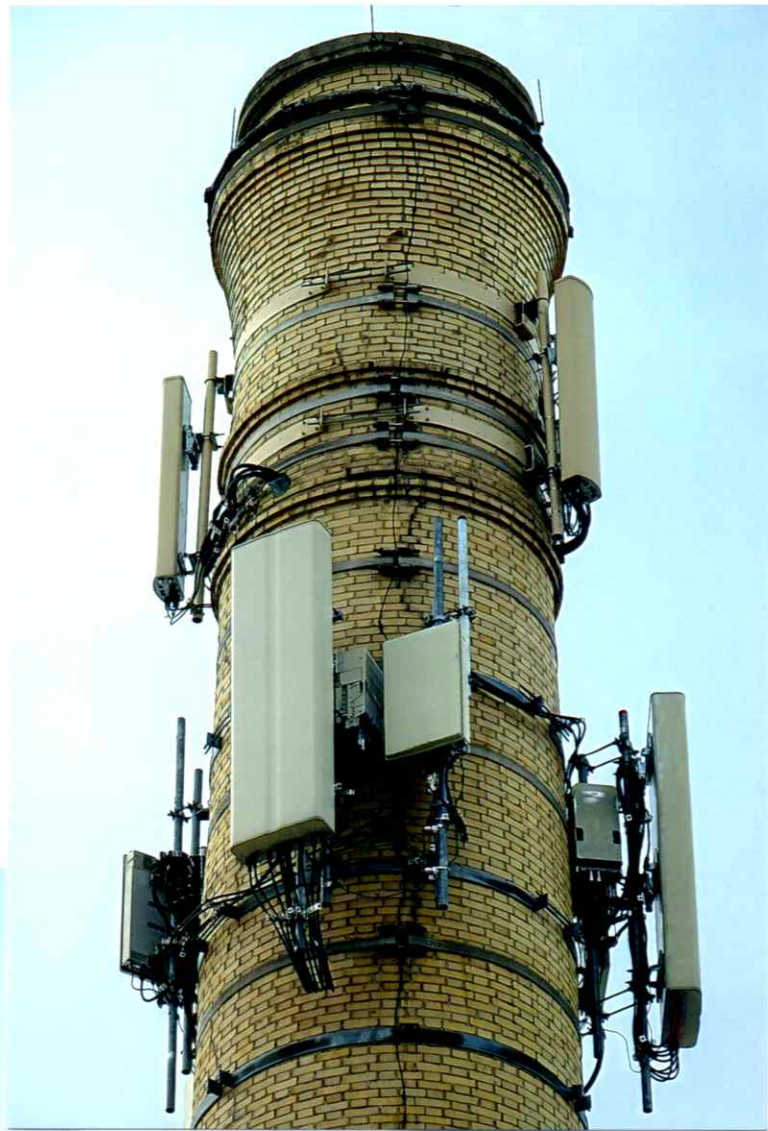
Fair exterior condition of the upper elevations of the east side. Mortar joints between the 95' and 75' level were recessed and deteriorated. Thin cracks and open joints existed along previously repaired cracks. All bands and antennas were secure.

- The open and deteriorated mortar joints below the 70'-0 level (approx. 10% / 200 SF) will be ground out as needed and the prepared mortar joints will be tuckpointed with an ASTM C270 Type N mortar. The joints will be rinsed of dust and debris prior to repointing.

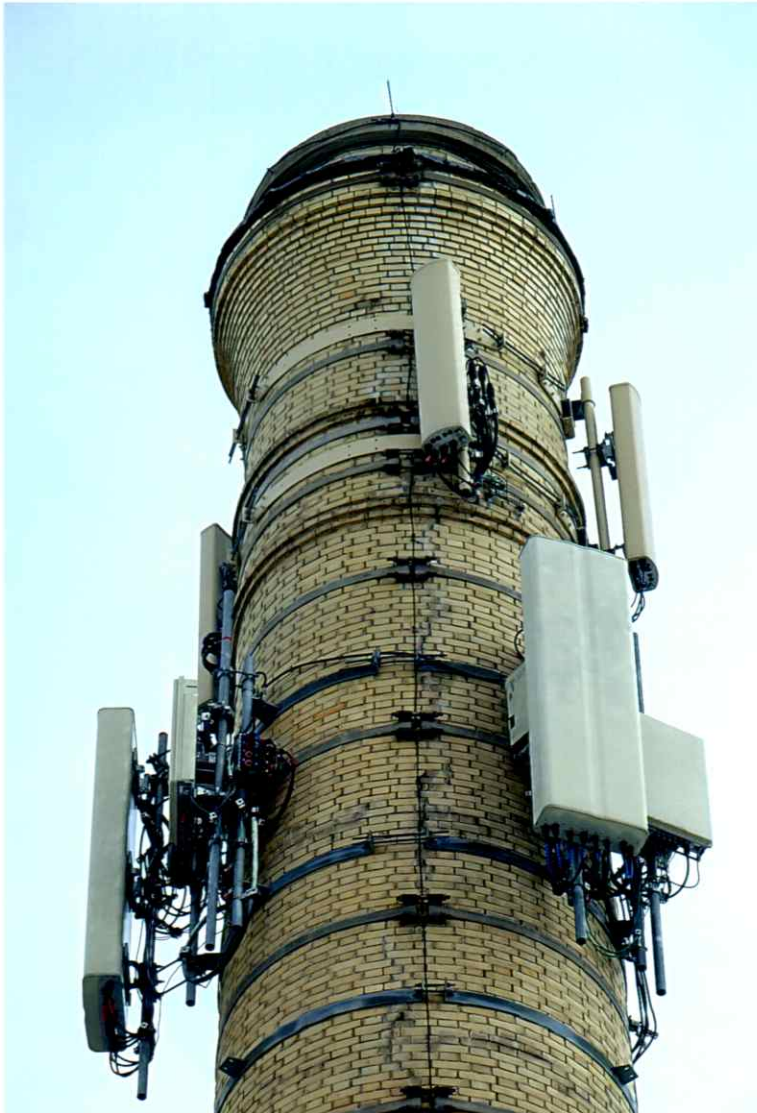
Photo 4.

Fair exterior condition of the upper elevations of the west side. Mortar joints between the 95' and 75' level were recessed and deteriorated. Thin cracks and open joints existed along previously repaired cracks. All bands and antennas were secure.

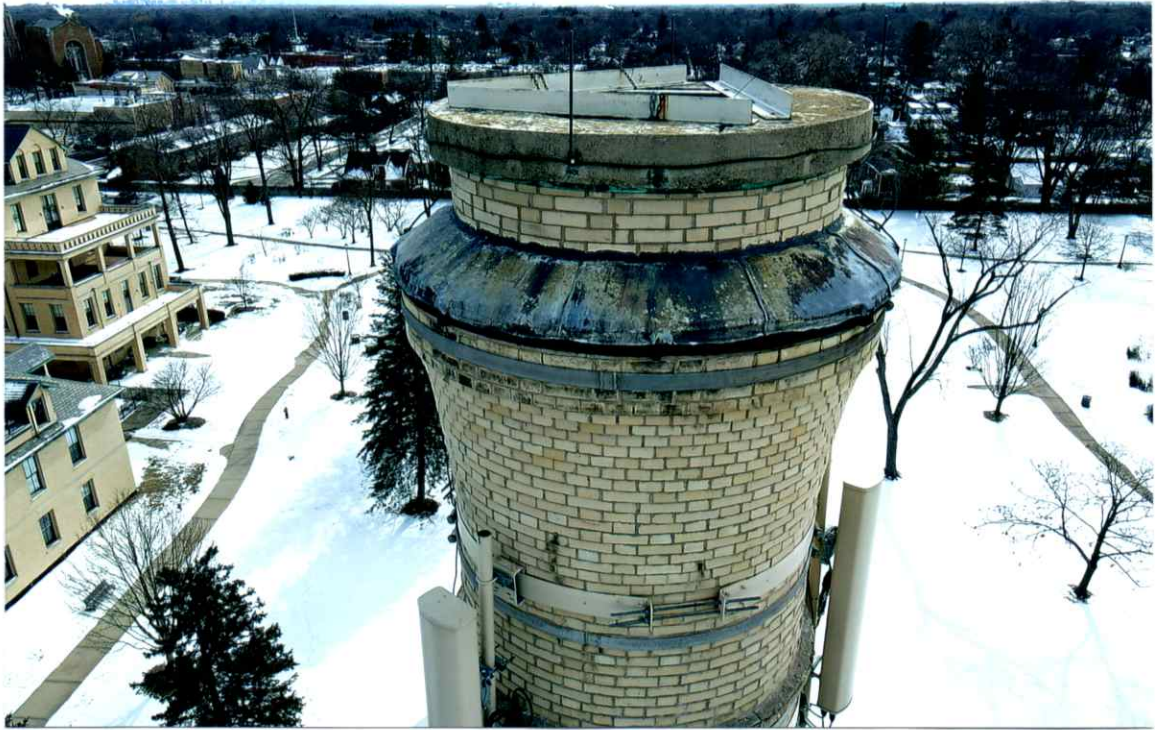
Photo 7. Overall good condition of the upper elevations of the north side. The uppermost exterior band and flashing were secure. Mortar joints were slightly weathered.

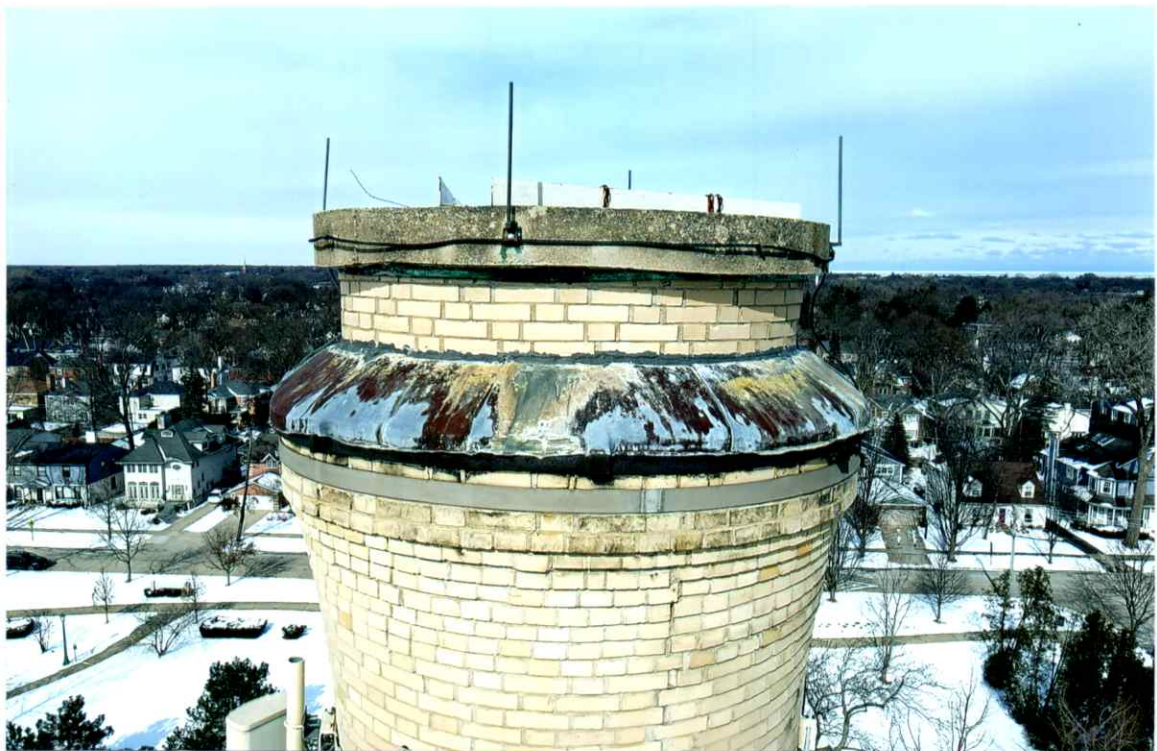
Photo 8. Overall good condition of the upper elevations of the south side. The uppermost exterior band and flashing were secure. A few open mortar joints were noted.

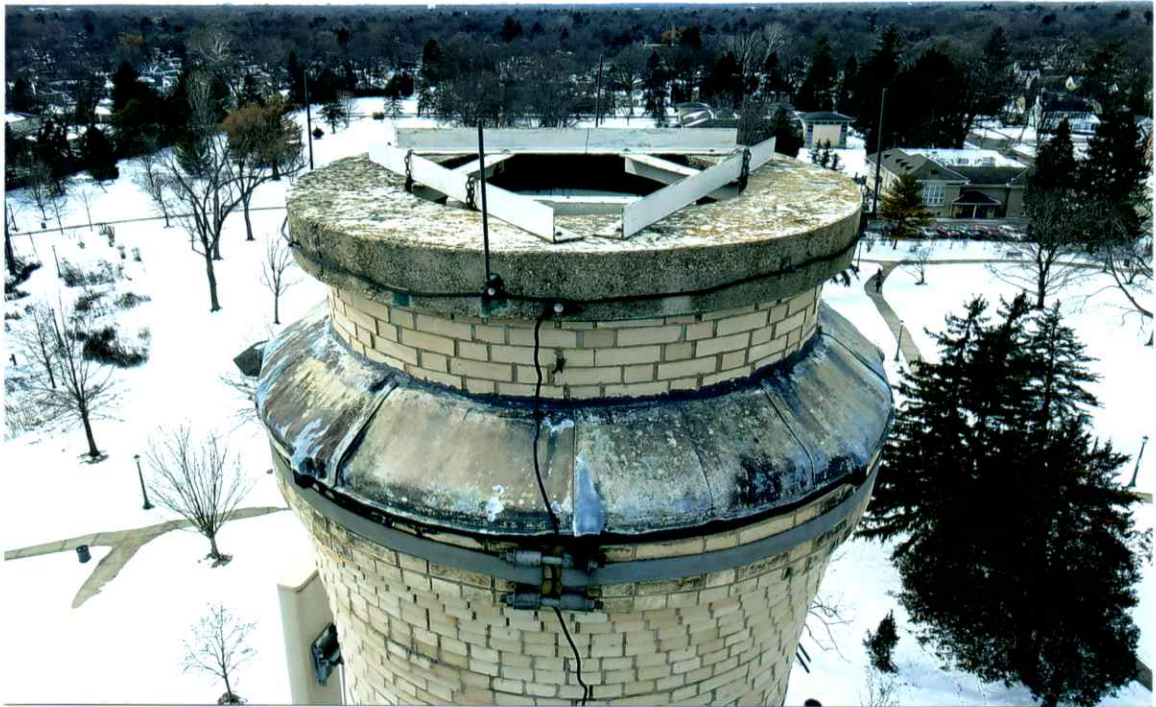
Photo 9. Overall good condition of the upper elevations of the east side. The uppermost exterior band and flashing were secure. Mortar joints were slightly weathered.

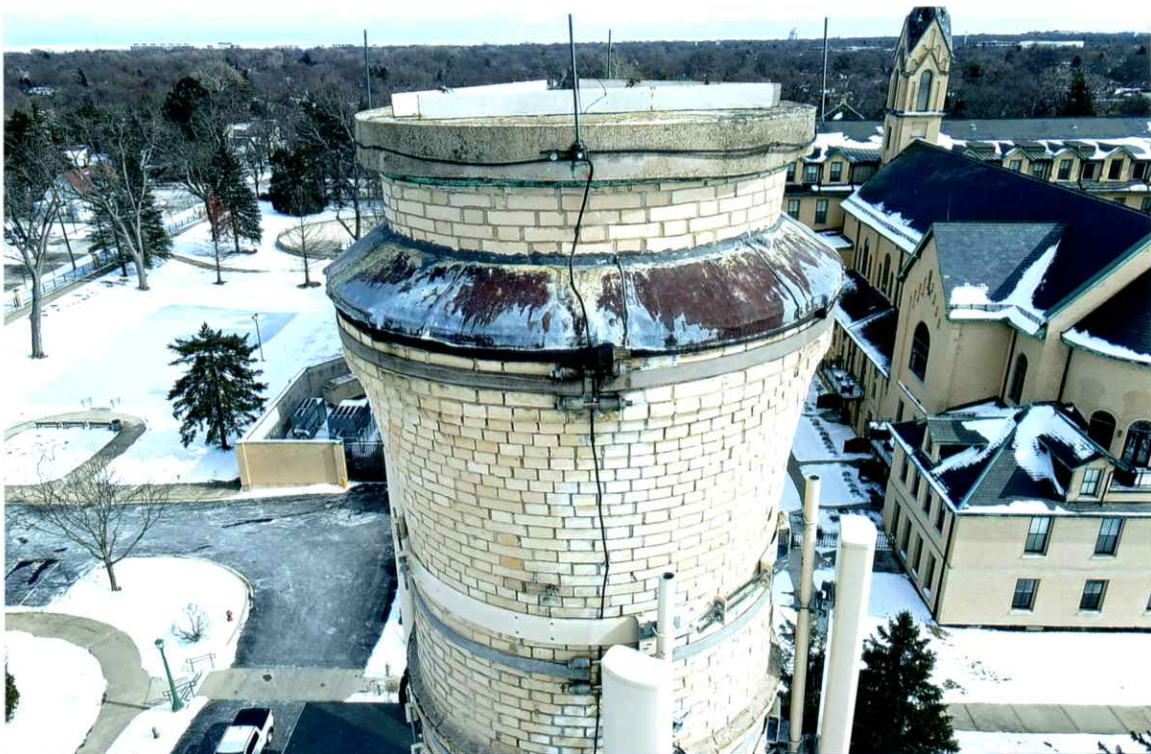
Photo 10. Overall good condition of the upper elevations of the west side. The uppermost exterior band and flashing were secure. Mortar joints were slightly weathered.

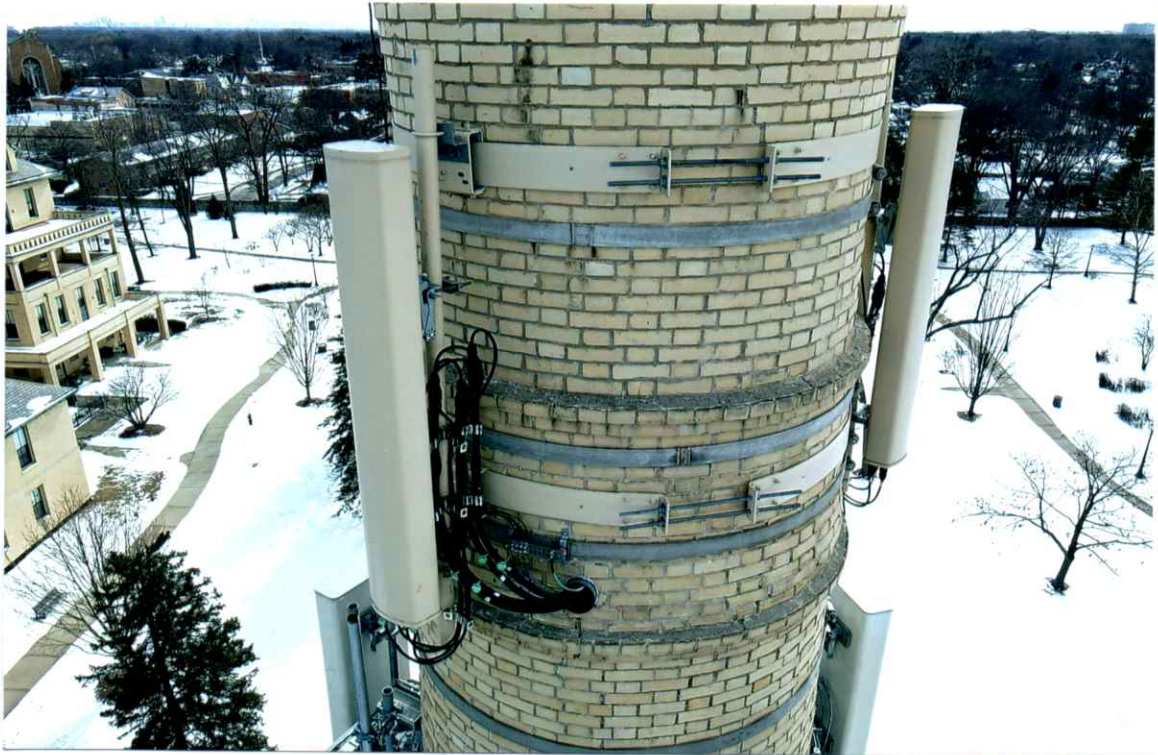
Photo 11. Overall good condition of the north side local to the upper level of antenna. All antennas and antenna support components were secure. Mortar joints were slightly weathered.

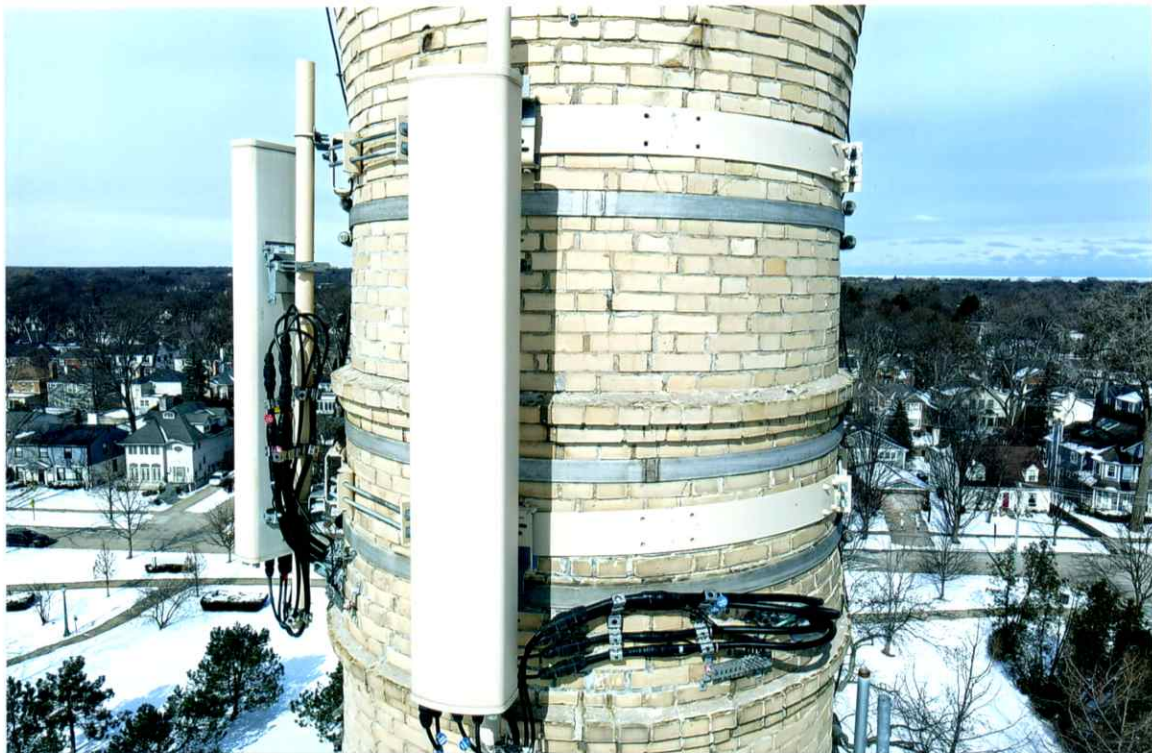
Photo 12. Overall good condition of the south side local to the upper level of antenna. All antennas and antenna support components were secure. Mortar joints were slightly weathered.

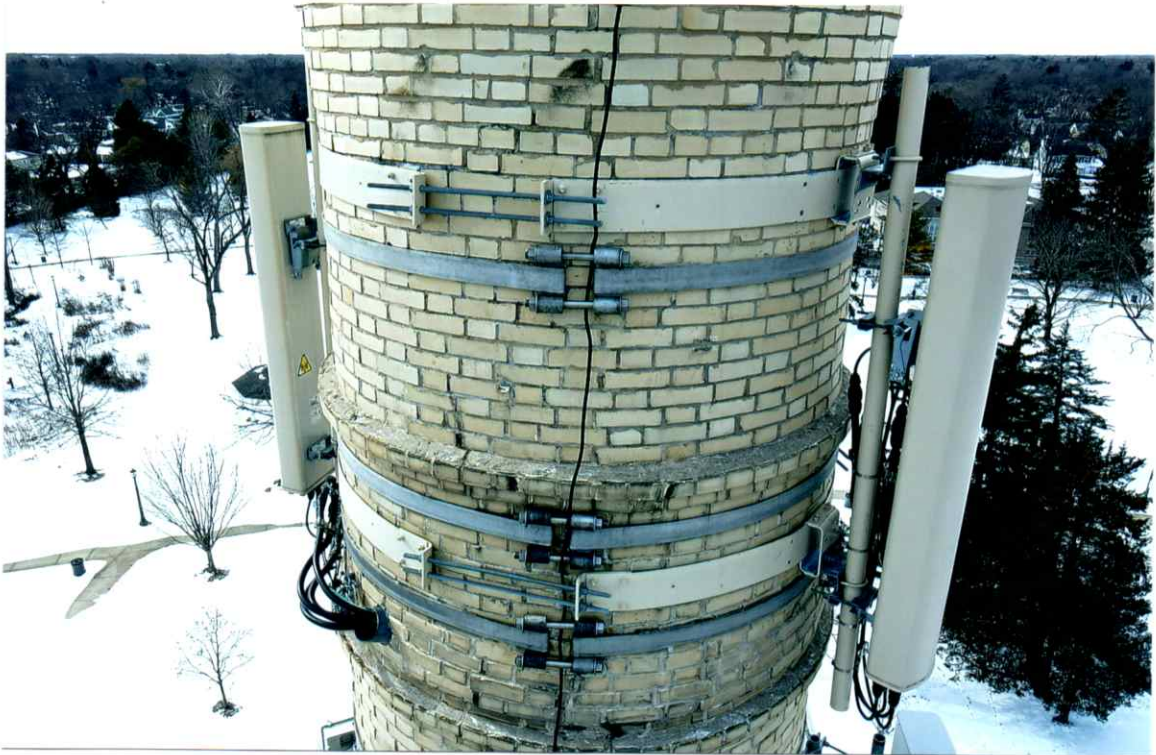
Photo 13. Overall good condition of the east side local to the upper level of antenna. All antennas and antenna support components were secure. Mortar joints were slightly weathered.

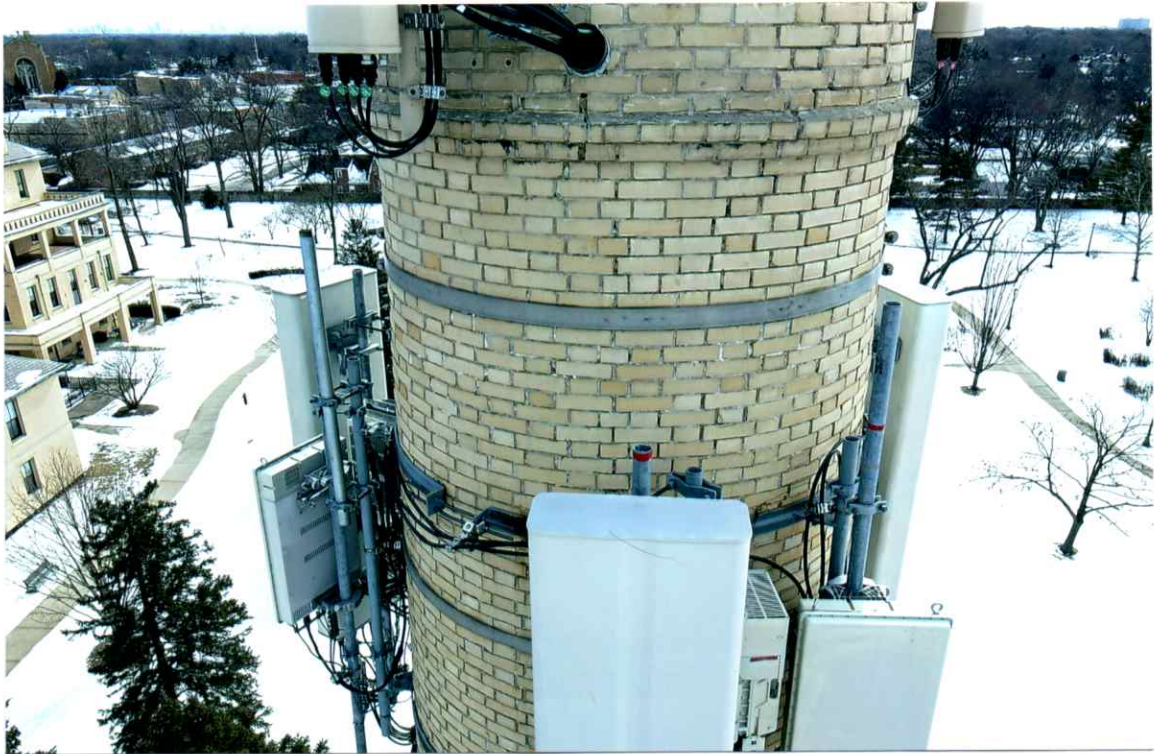
Photo 15. Fair exterior condition of mortar joints near the 93' level (north side). Mortar joints were slightly eroded and recessed in this region.

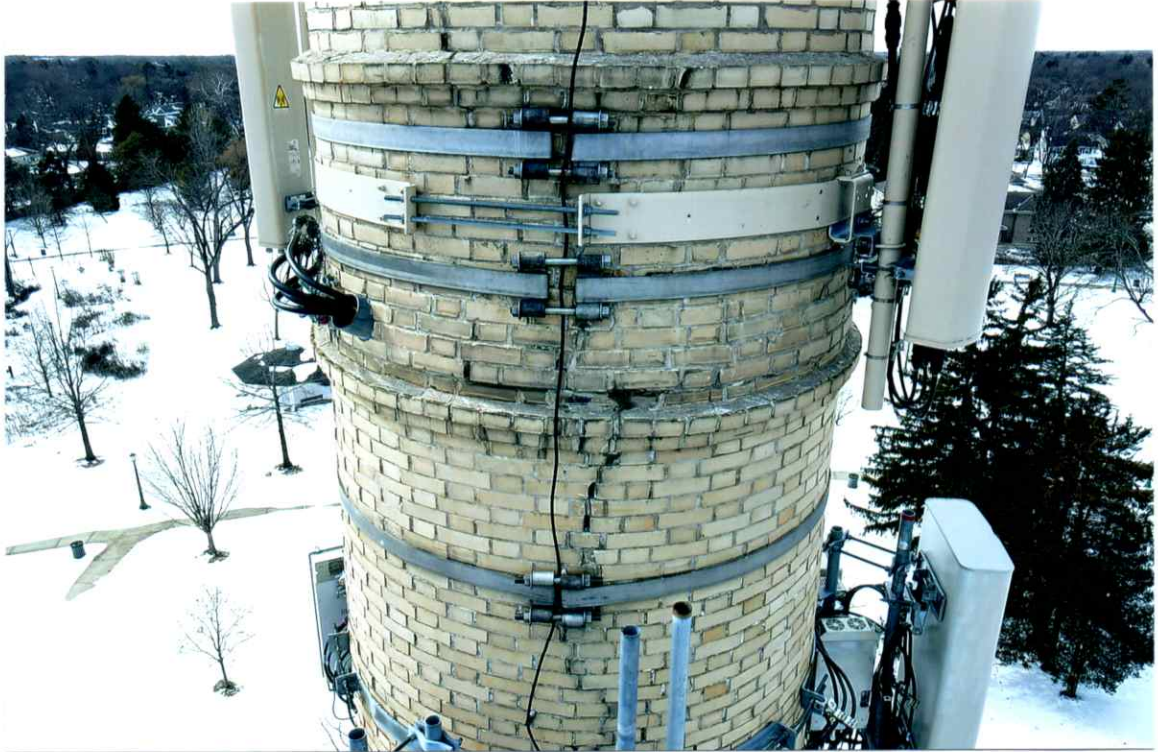
Photo 17. Fair exterior condition of mortar joints near the 93' level (east side). Past repairs to the crack were in poor condition (see Photo 20).

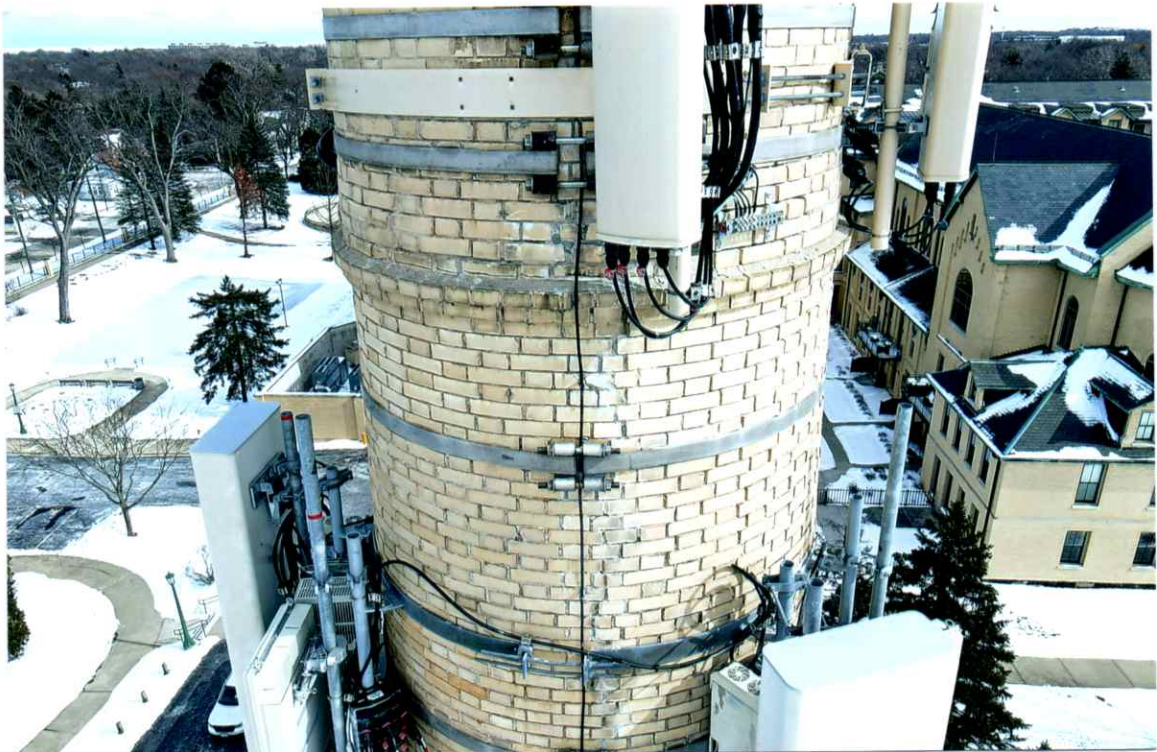
Photo 18. Fair exterior condition of mortar joints near the 93' level (west side). Past repairs to the crack were in fair condition in this region.

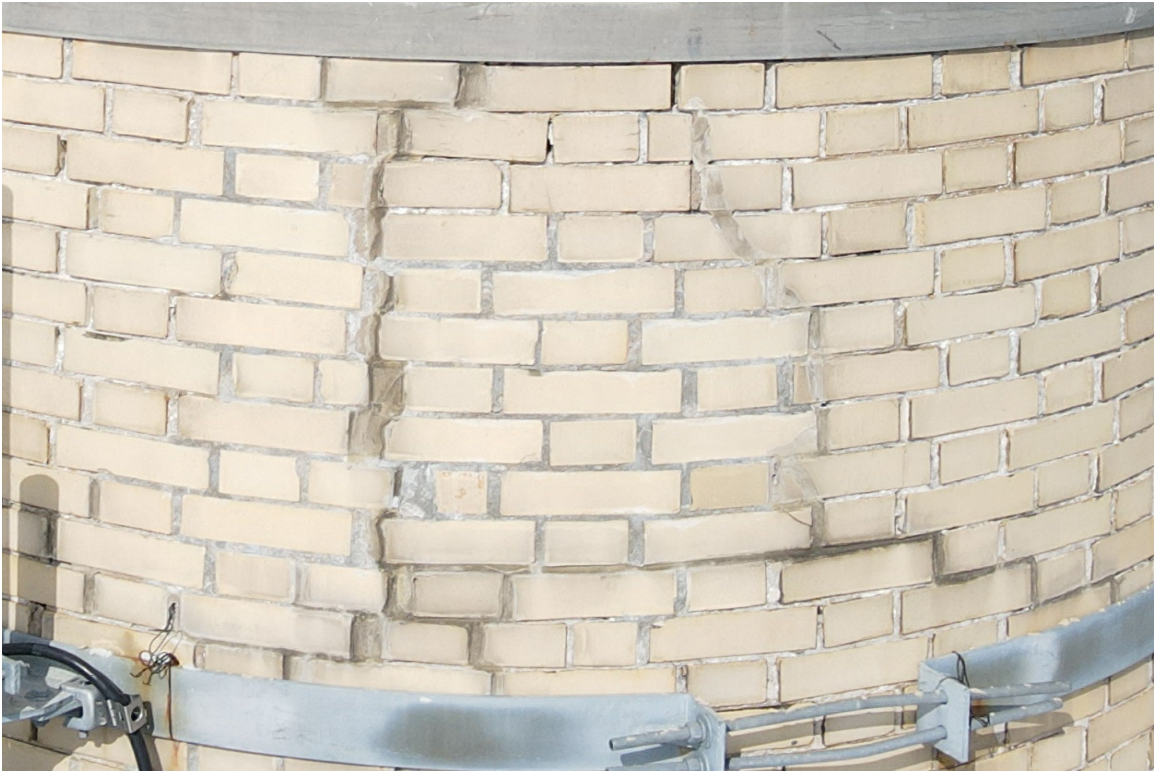
Photo 19. Close-up of the good condition of the repaired crack (south side, 93' level).

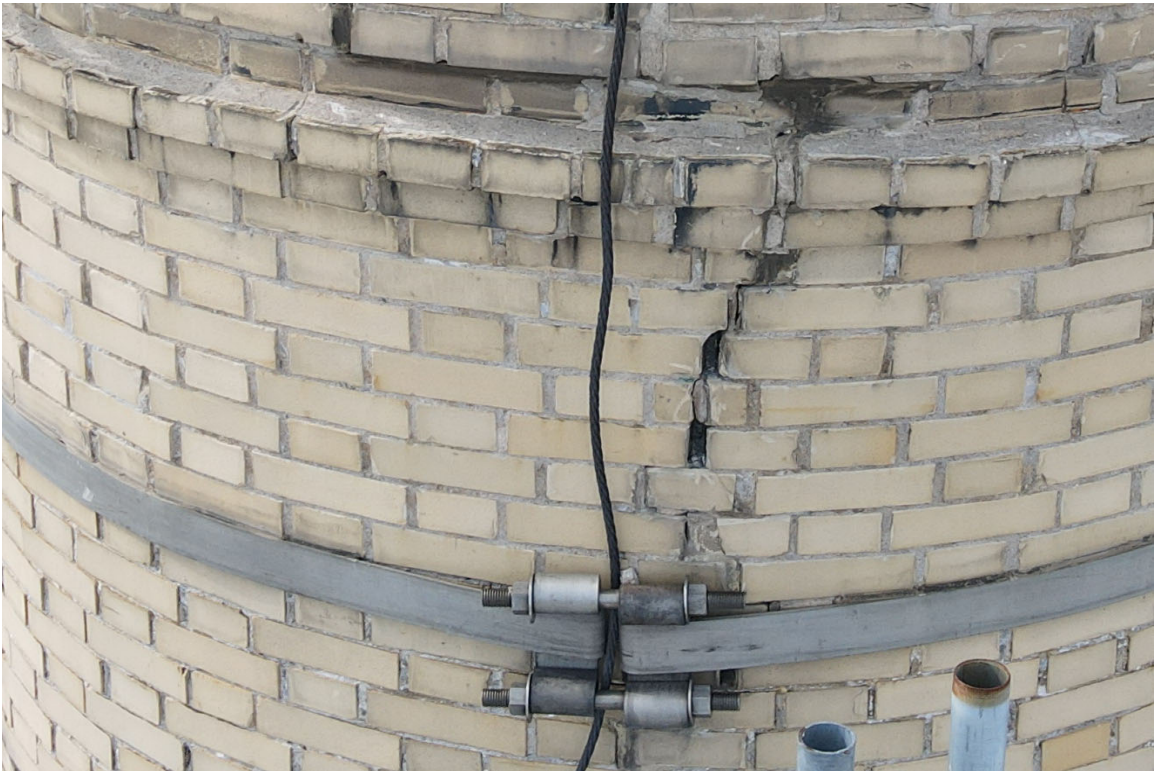
Photo 20. Close-up of the poor condition of the repaired crack (south side, 93' level).

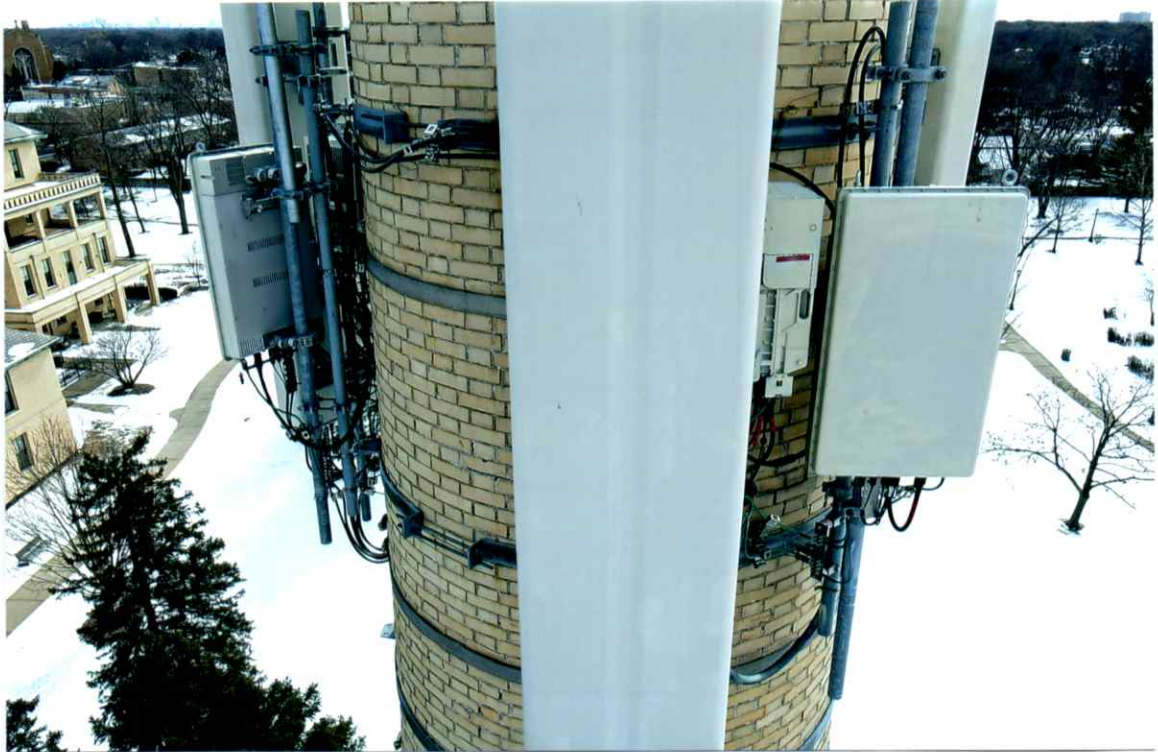
Photo 21. Overall good condition of the north side local to the lower level of antenna. All antennas and support components were secure. Mortar joints were only slightly weathered.

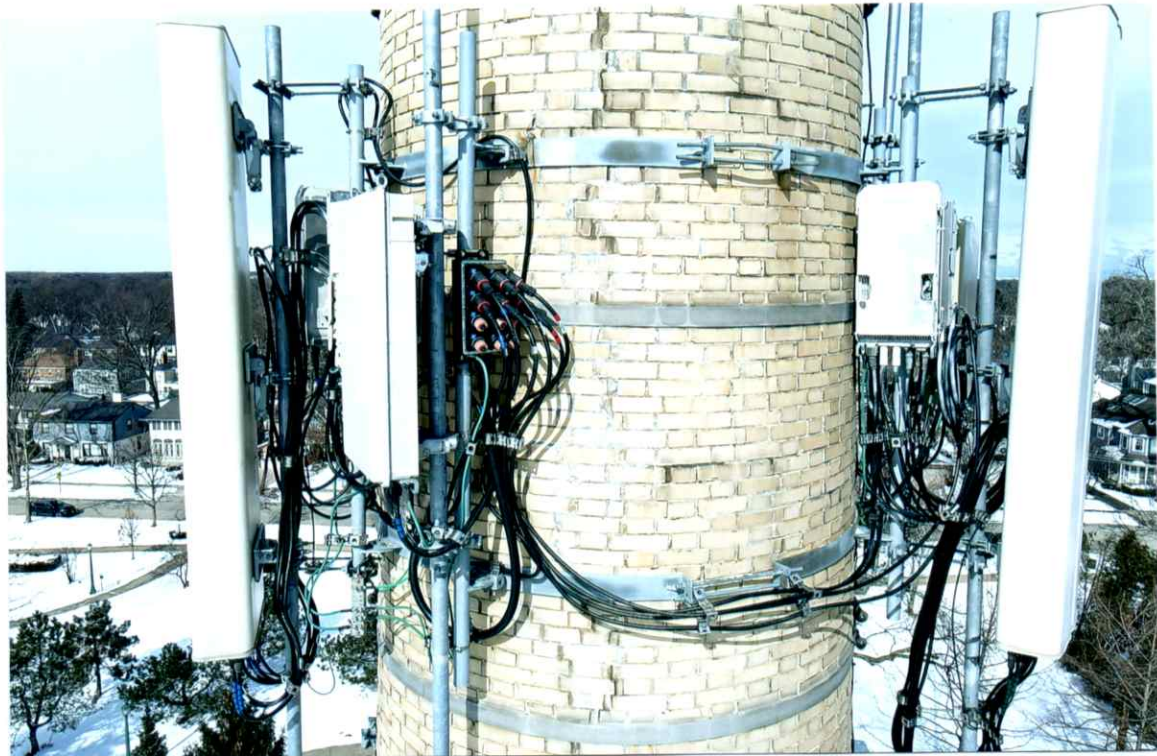
Photo 22. Overall good condition of the south side local to the lower level of antenna. All antennas and support components were secure. Past repairs along the crack were sound.

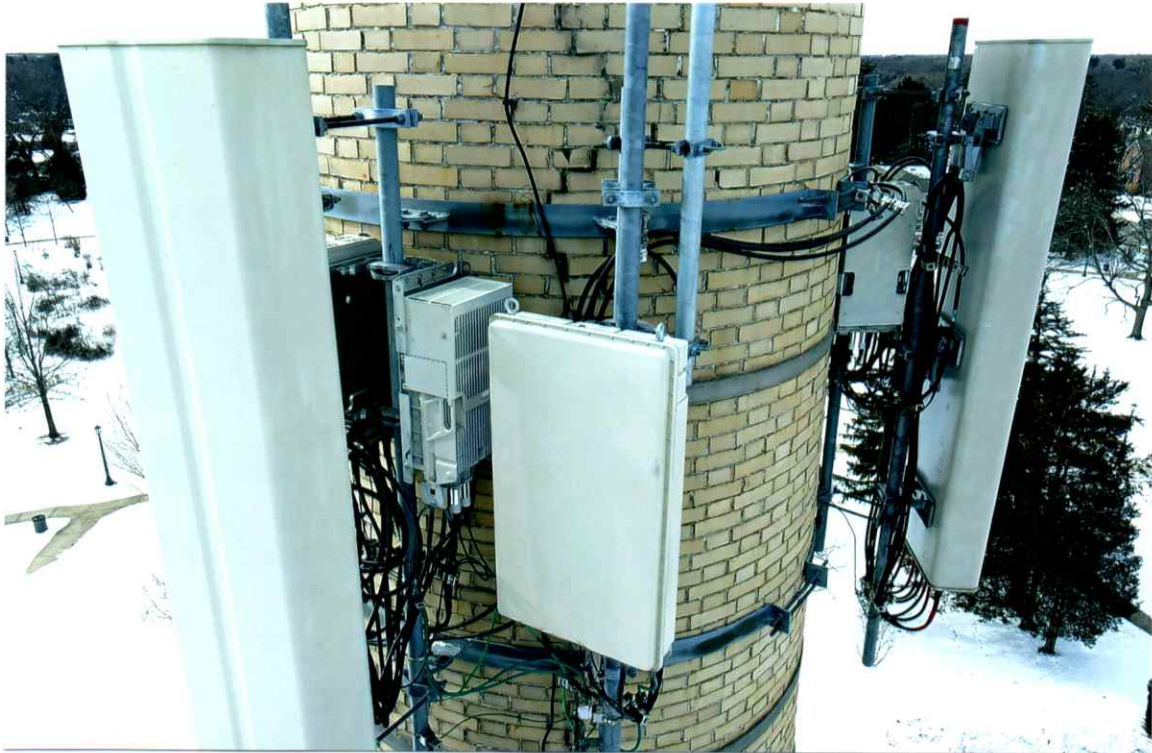
Photo 23. Overall good condition of the east side local to the upper level of antenna. All antennas and antenna support components were secure. Past repairs along the crack were sound.

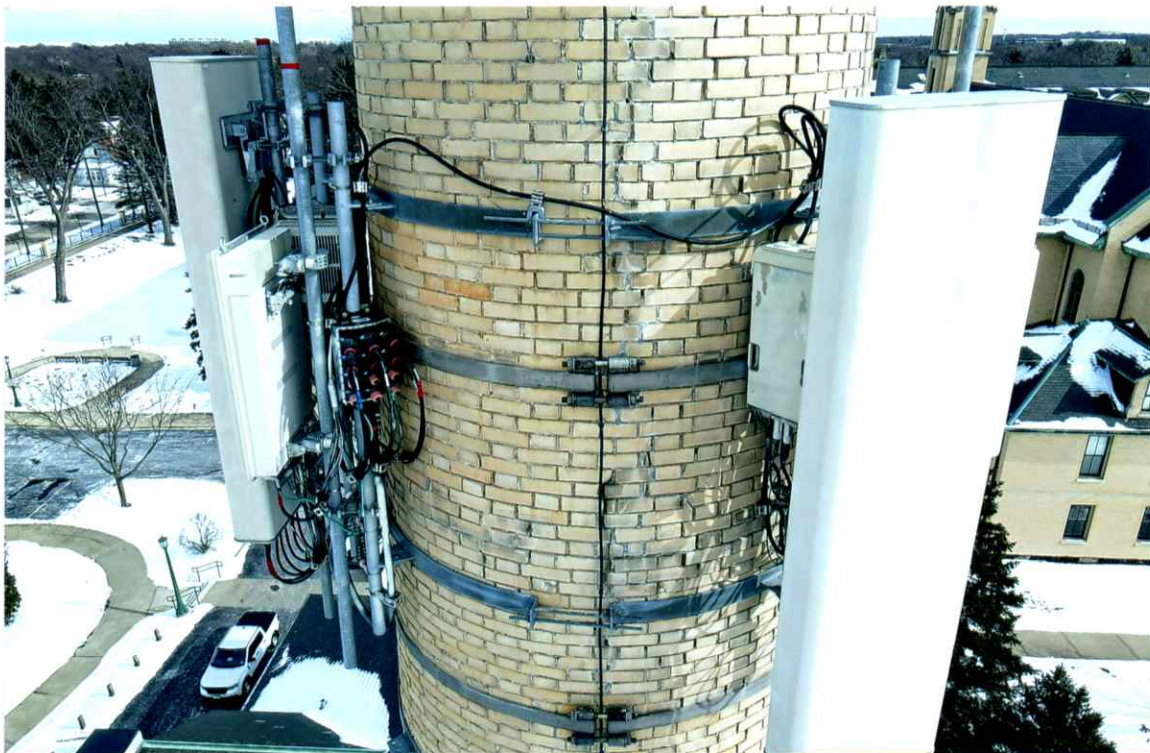
Photo 24. Overall good condition of the west side local to the upper level of antenna. Antennas and support components were secure. Past repairs along the crack were sound (Photo 29).

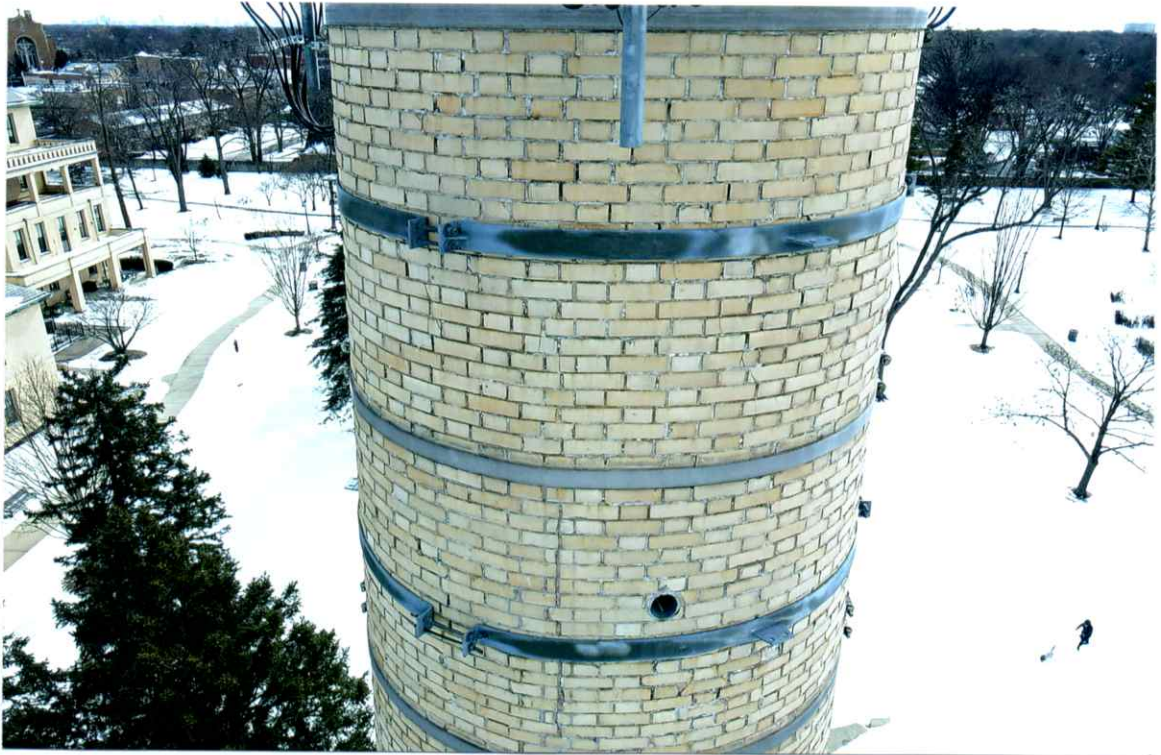
Photo 25. Fair exterior condition of the north side local to the 79' level. All bands were secure. Mortar joints were weathered and recessed.

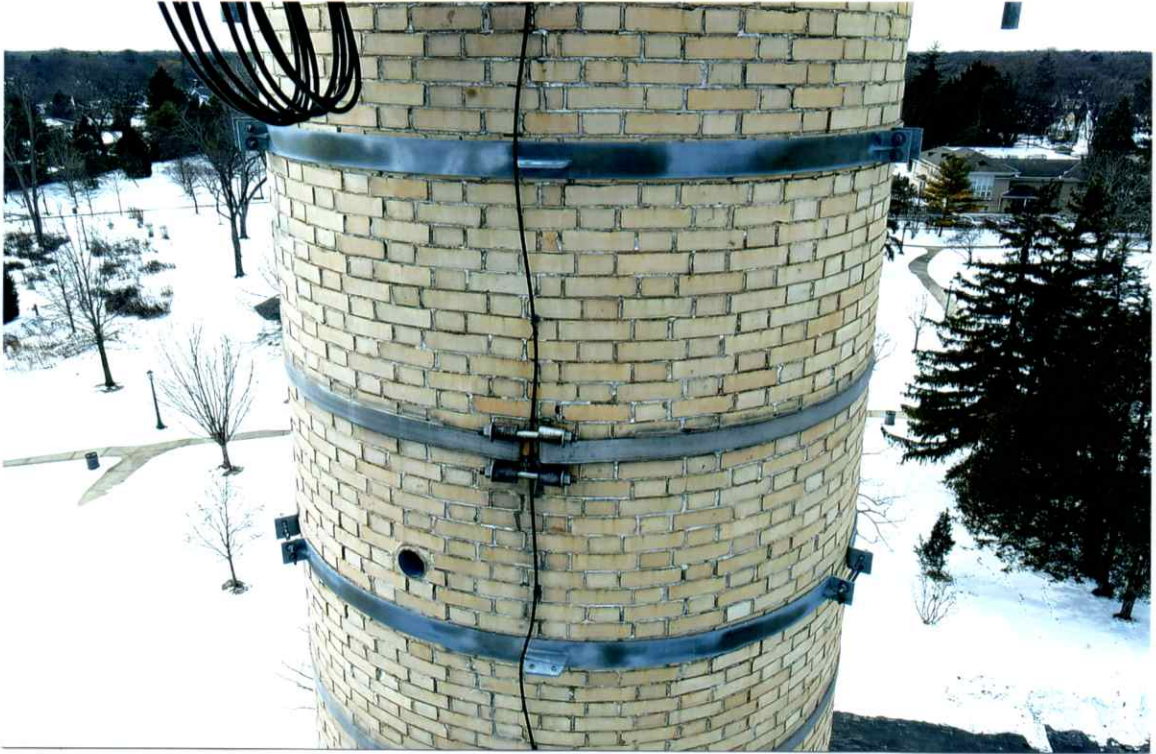
Photo 27. Fair exterior condition of the east side local to the 79' level. All bands were secure. Mortar joints were weathered and recessed.

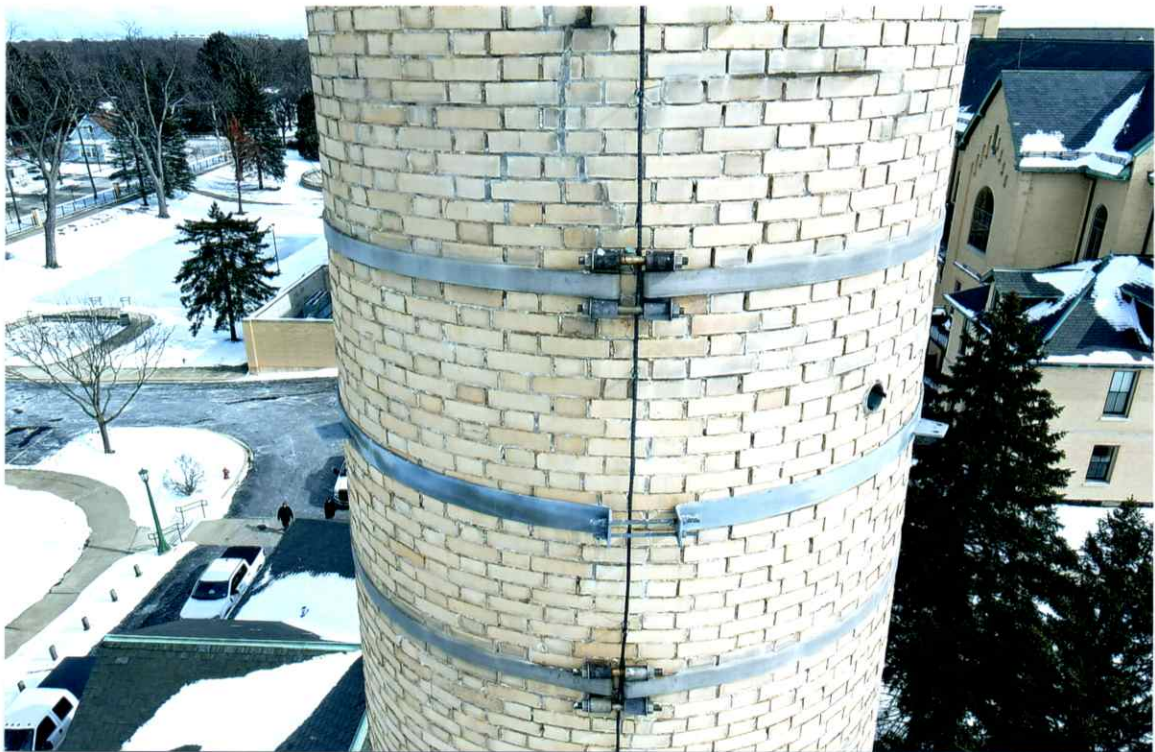
Photo 28. Fair exterior condition of the west side local to the 79' level. All bands were secure. Mortar joints were weathered and recessed.

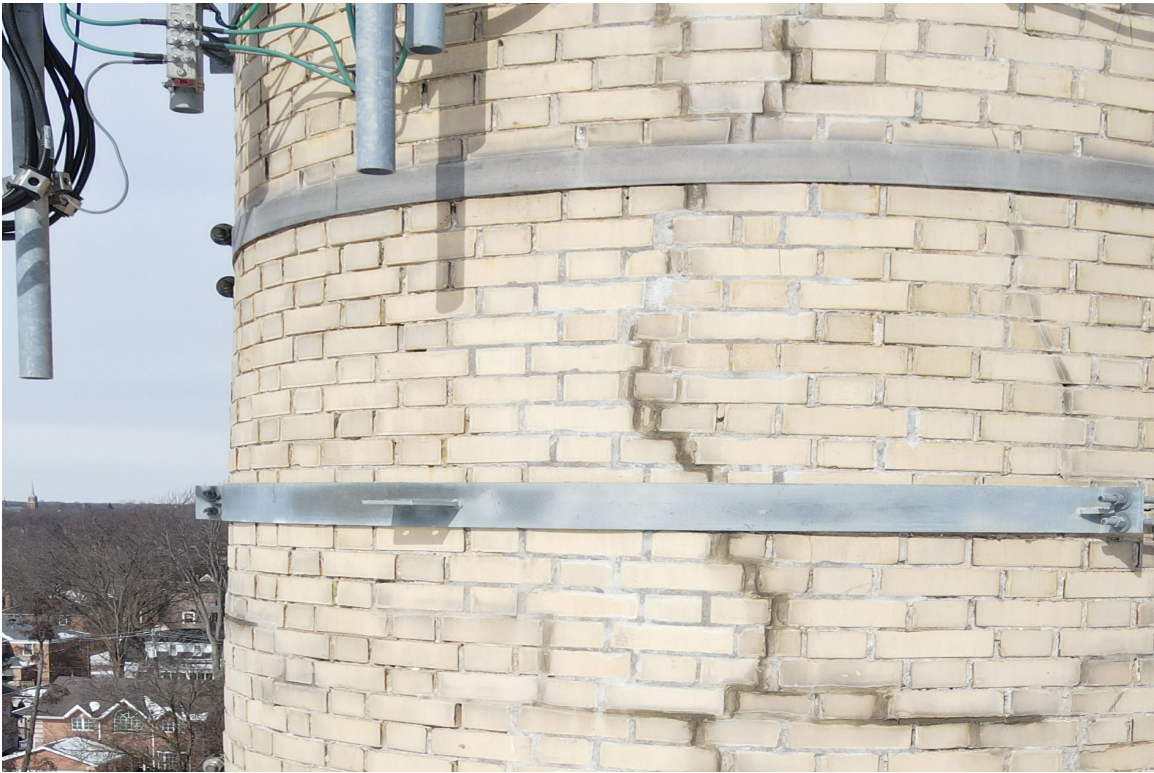
Photo 30. Close-up of the fair condition of the repaired crack (south side, 79' level).

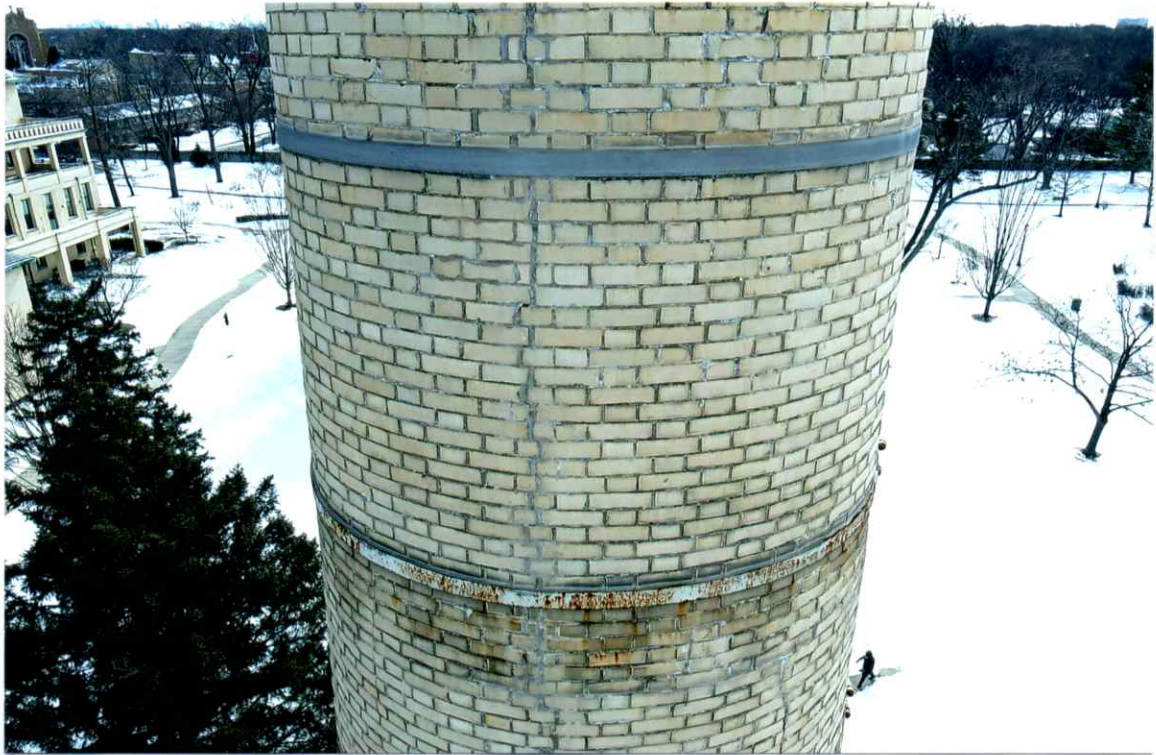
Photo 31. Fair exterior condition of the north side local to the 73' level. Mortar joints were weathered and recessed. Repairs to the crack were in fair condition (see Photo 39).
