**Wilmette Park District
Mallinckrodt Chimney
Masonry Repairs**

**INVITATION TO BID 2026
Mallinckrodt Chimney
Masonry Repair
WILMETTE PARK DISTRICT**

The Wilmette Park District is seeking sealed base bids for masonry repairs to the chimney that sits on 1929 Elmwood AVE Wilmette , IL 60091 located at our Mallinckrodt facility. Currently, the chimney houses Verizon Wireless telecommunications equipment.

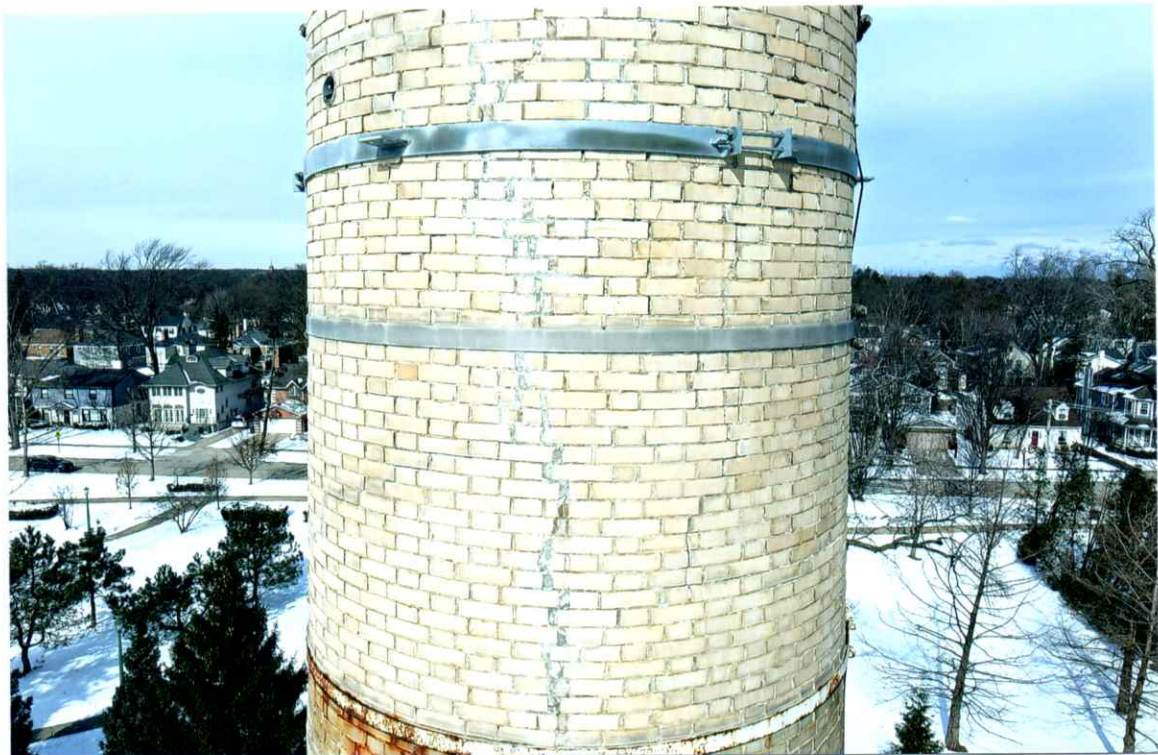
Photo 32. Fair exterior condition of the south side local to the 73' level. All bands were secure. Past repairs along the crack were sound.

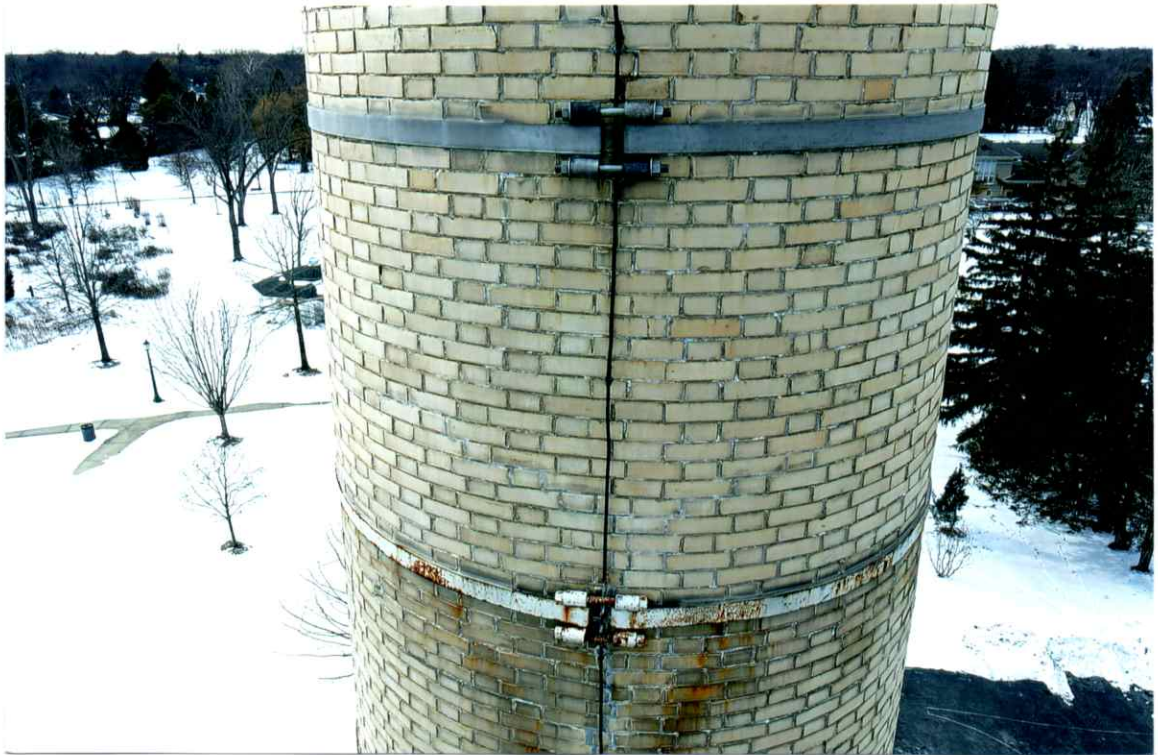
Photo 33. Fair exterior condition of the east side local to the 73' level. All bands were secure. Mortar joints were weathered and recessed.

- The open and deteriorated mortar joints below the 70'-0 level (approx. 10% / 200 SF) will be ground out as needed and the prepared mortar joints will be tuckpointed with an ASTM C270 Type N mortar. The joints will be rinsed of dust and debris prior to repointing.

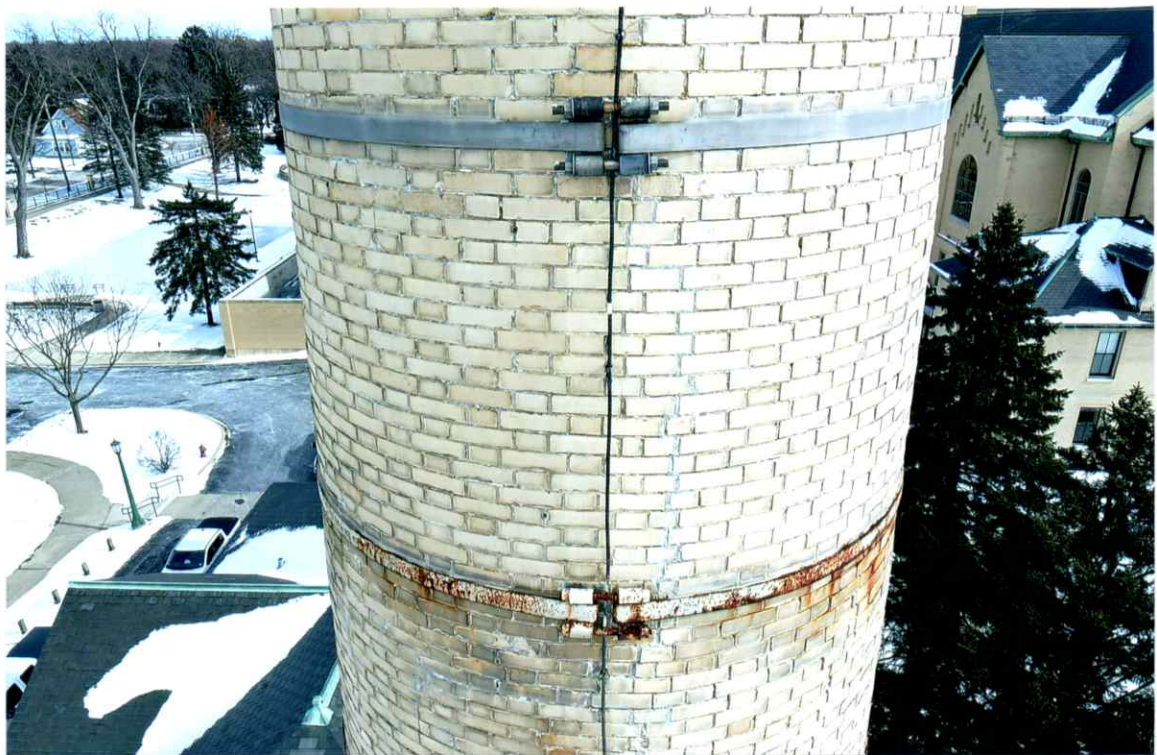
Photo 34. Fair exterior condition of the west side local to the 73' level. All bands were secure. Mortar joints were weathered and recessed.

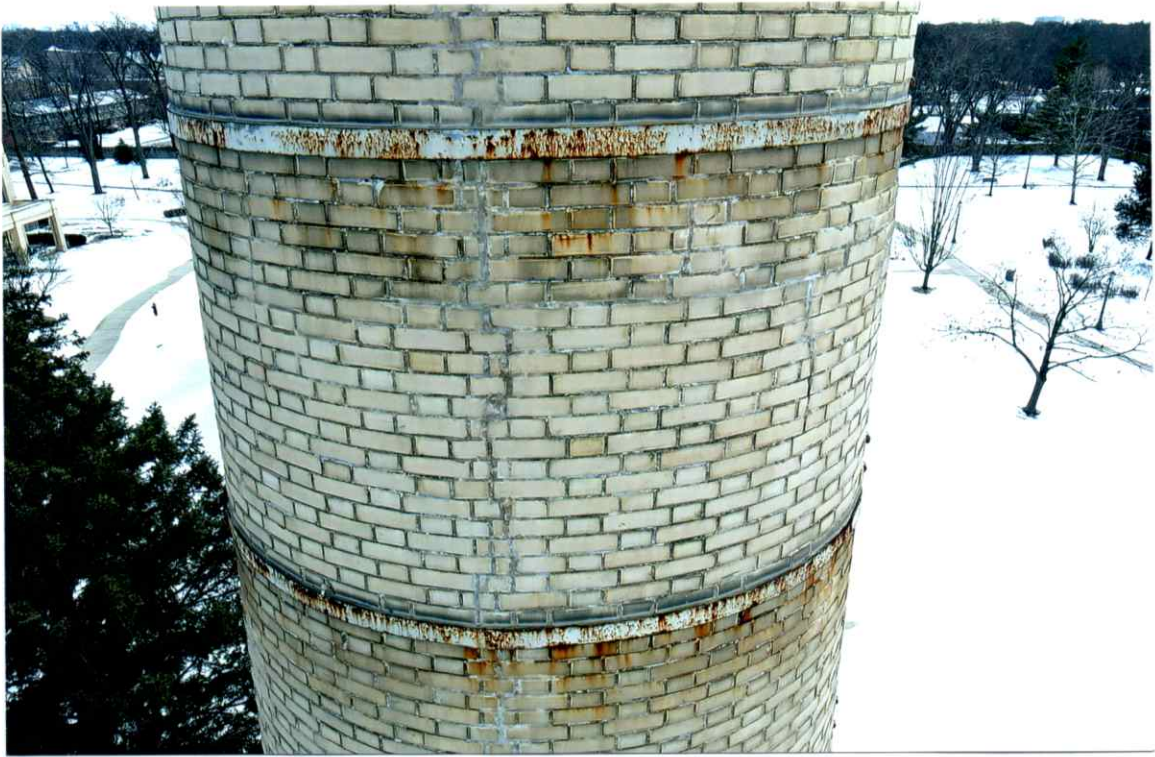
Photo 35. Fair exterior condition of the north side local to the 67' level. Mortar joints were weathered and recessed. Repairs to the crack were in fair condition (see Photo 40).

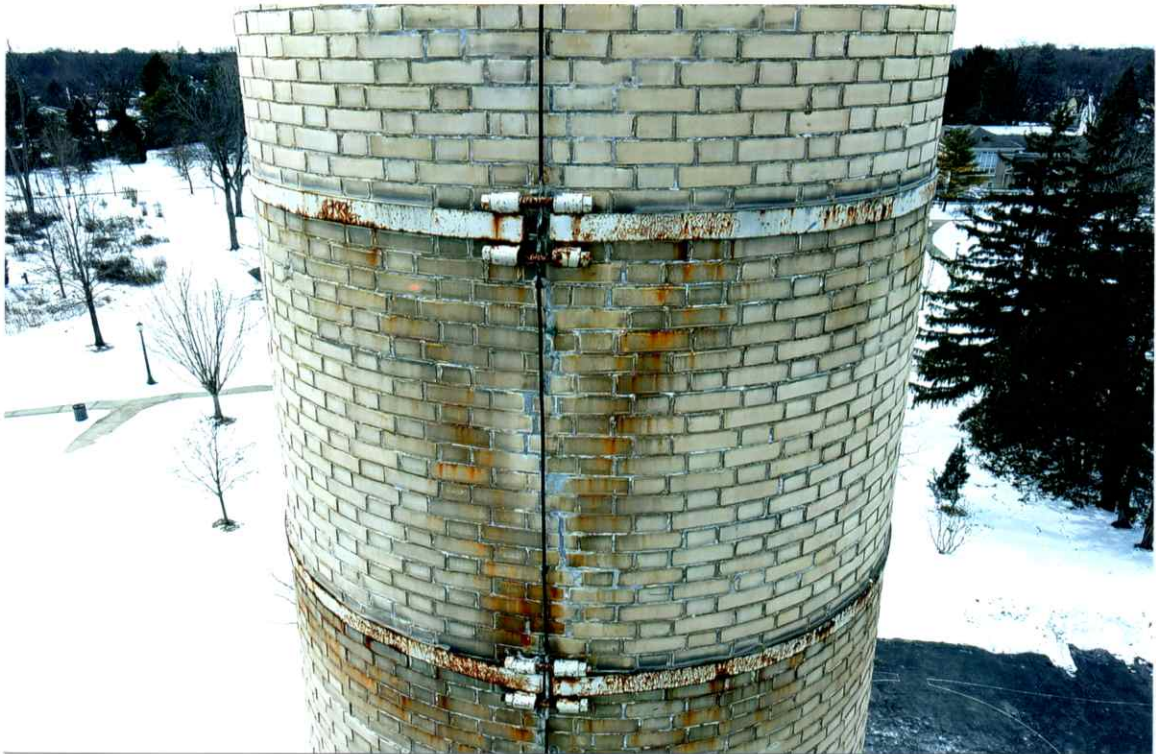
Photo 37. Fair exterior condition of the east side local to the 67' level. All bands were secure. Mortar joints were weathered and recessed.

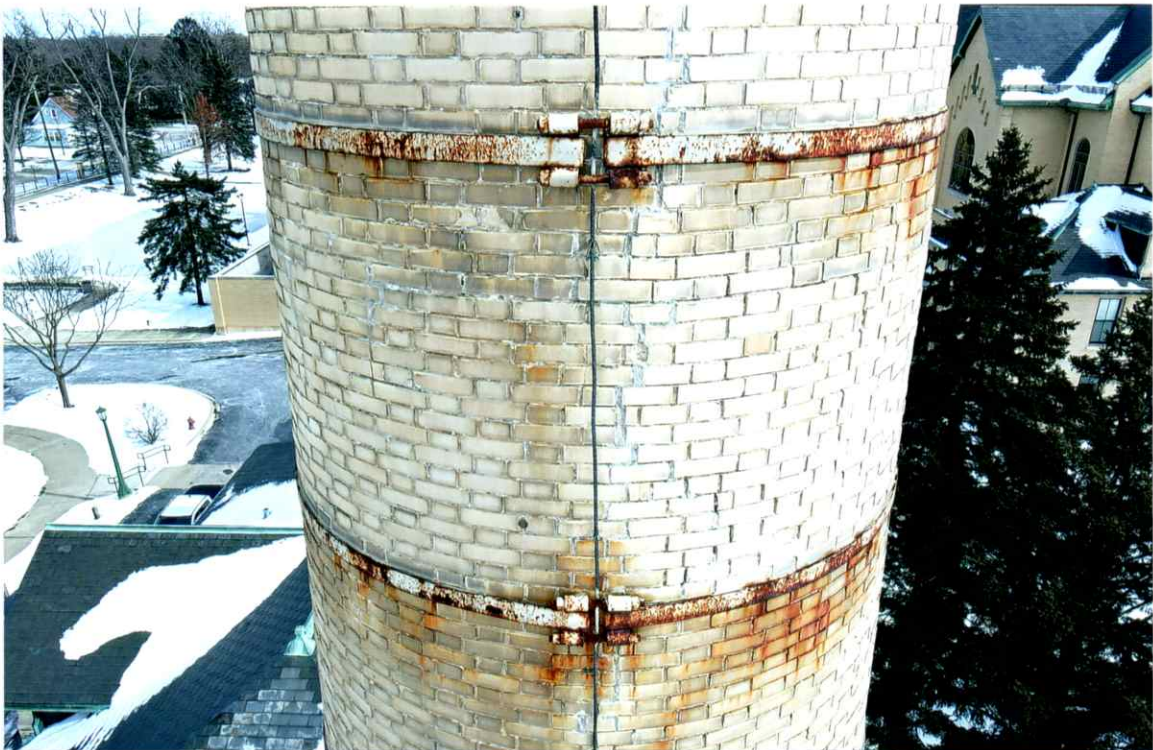
Photo 38. Fair exterior condition of the west side local to the 68' level. All bands were secure. Mortar joints were weathered and recessed.

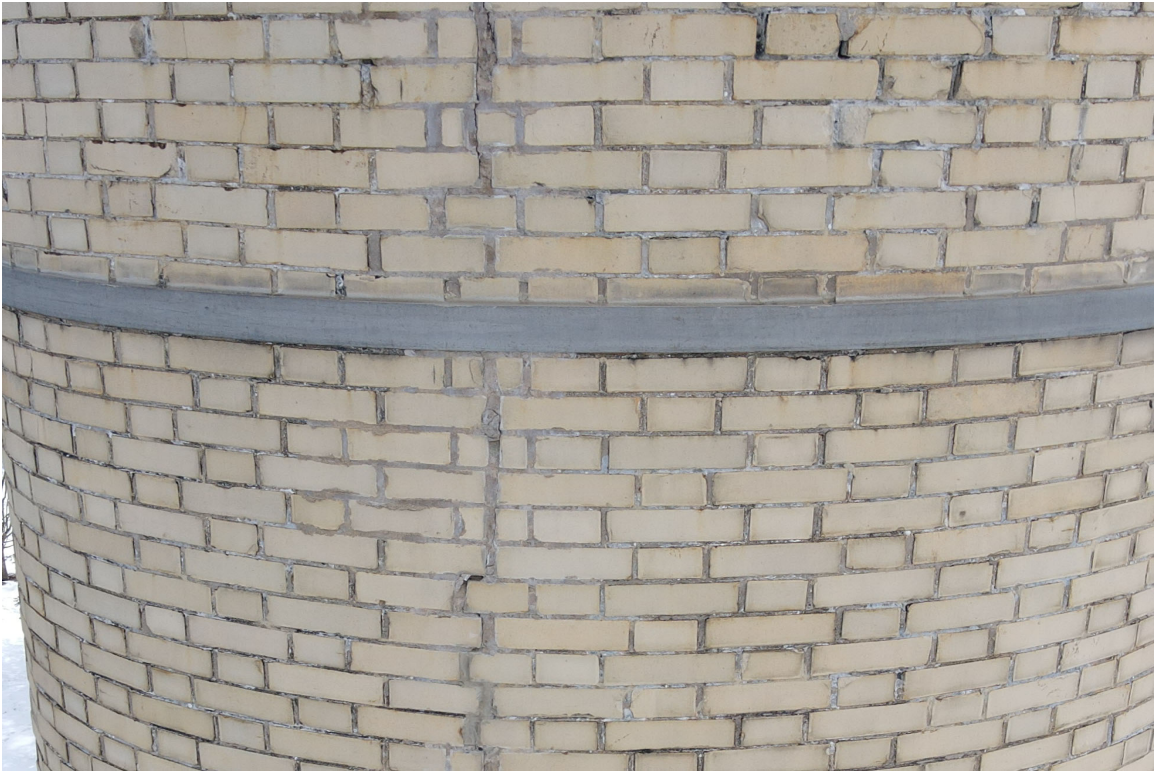
Photo 39. Close-up of the good condition of the repaired crack (north side, 73' level).

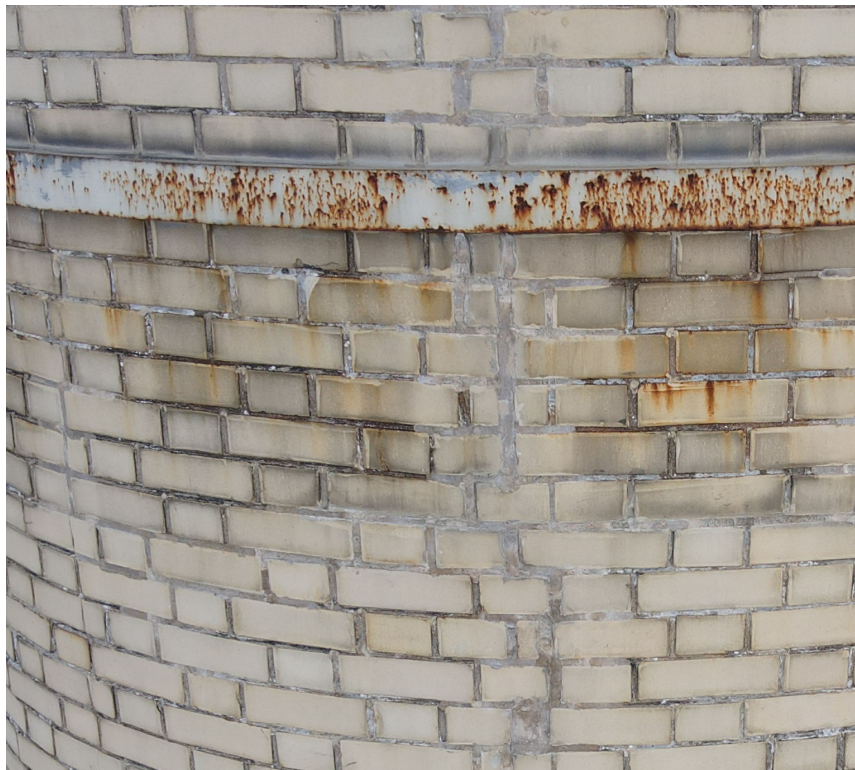
Photo 40. Close-up of the good condition of the repaired crack (north side, 67' level).

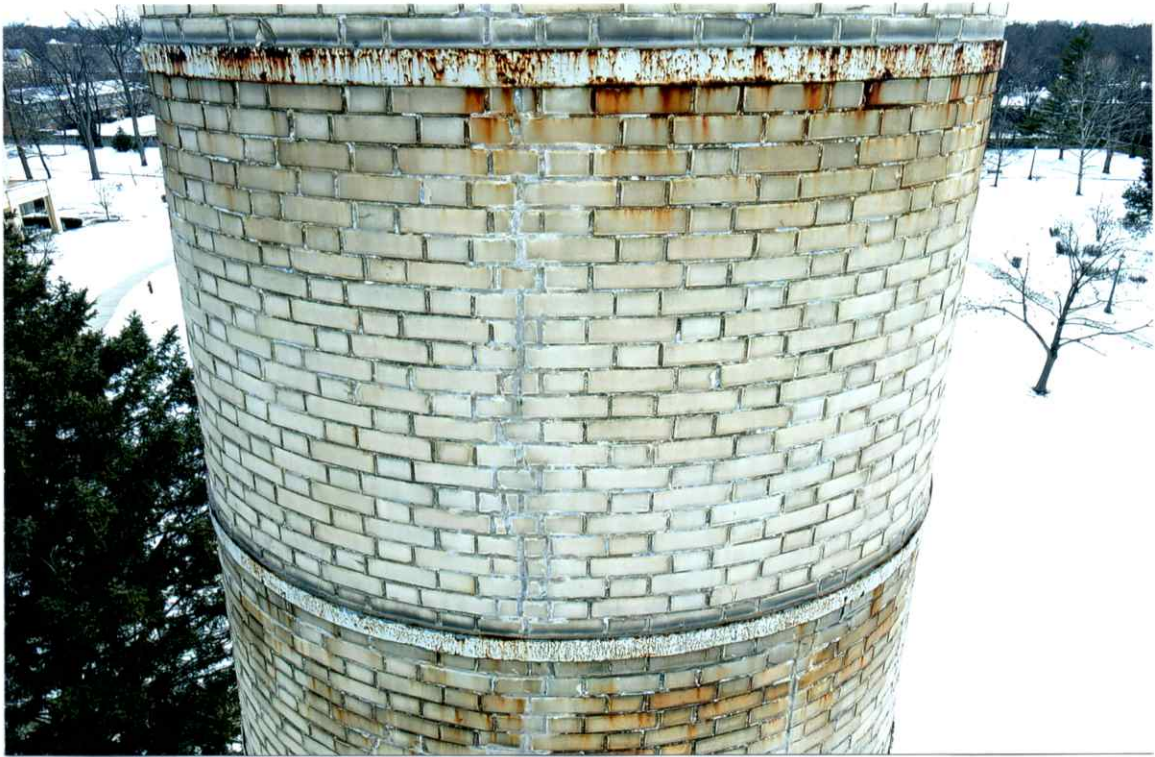
Photo 41. Good exterior condition of the north side local to the 61' level. Mortar joints were only slightly weathered. Repairs to the crack were sound.

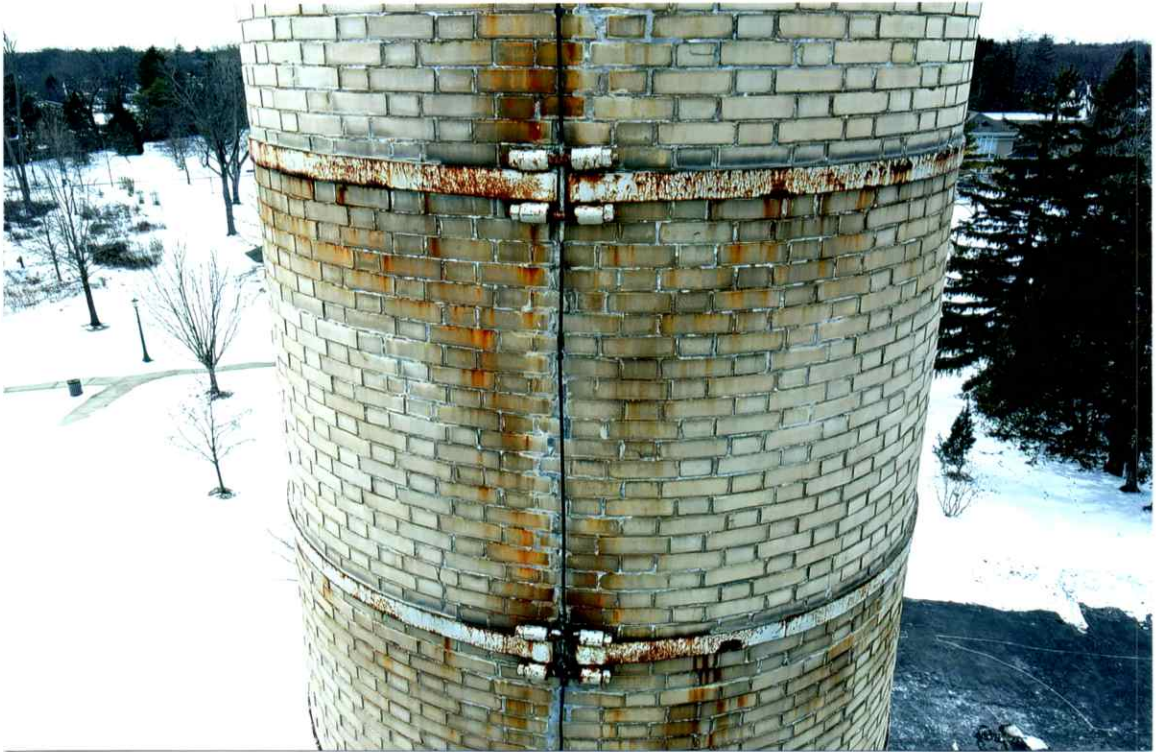
Photo 43. Good exterior condition of the east side local to the 61' level. Mortar joints were only slightly weathered. Repairs to the crack were sound (see Photo 49).

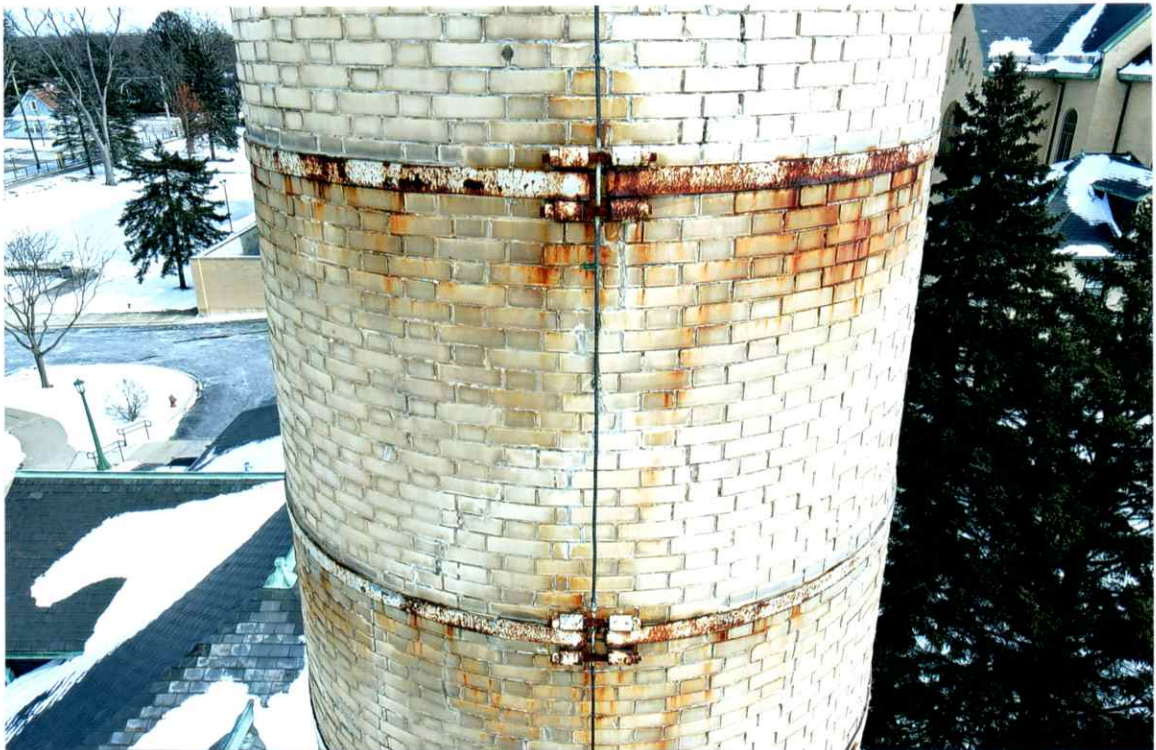
Photo 44. Good exterior condition of the west side local to the 61' level. Mortar joints were only slightly weathered. Repairs to the crack were sound.

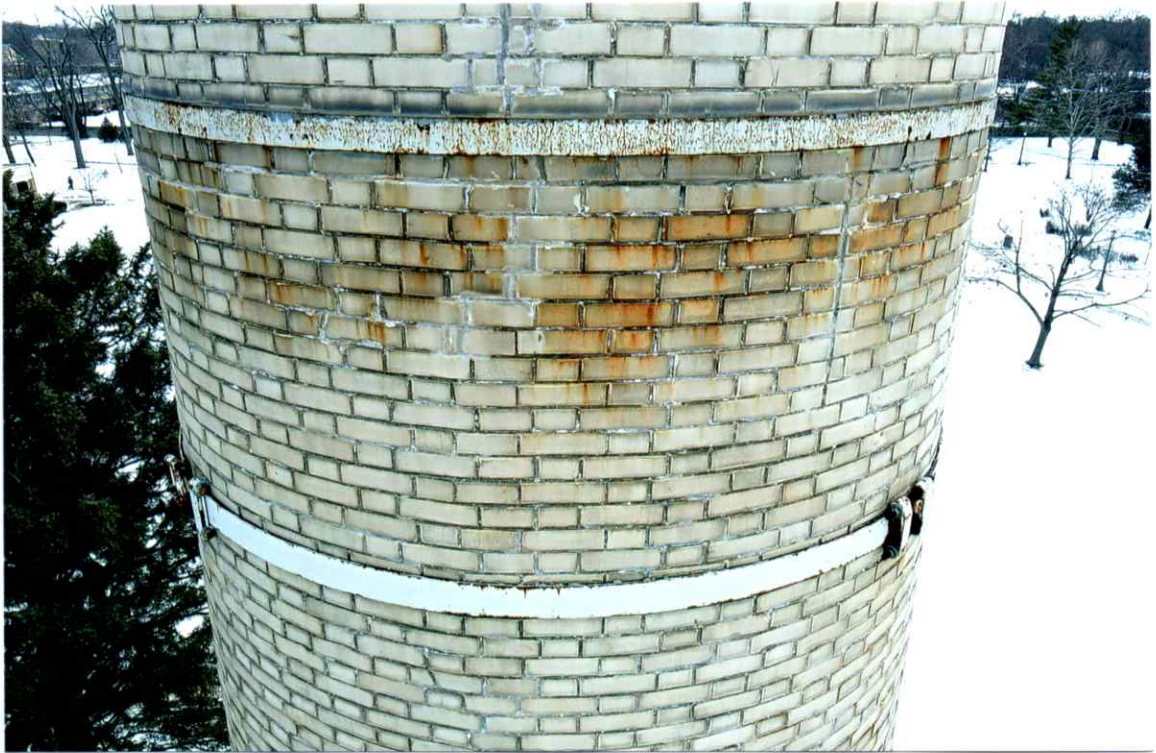
Photo 45. Good exterior condition of the north side local to the 56' level. Mortar joints were only slightly weathered. Repairs to the crack were sound.

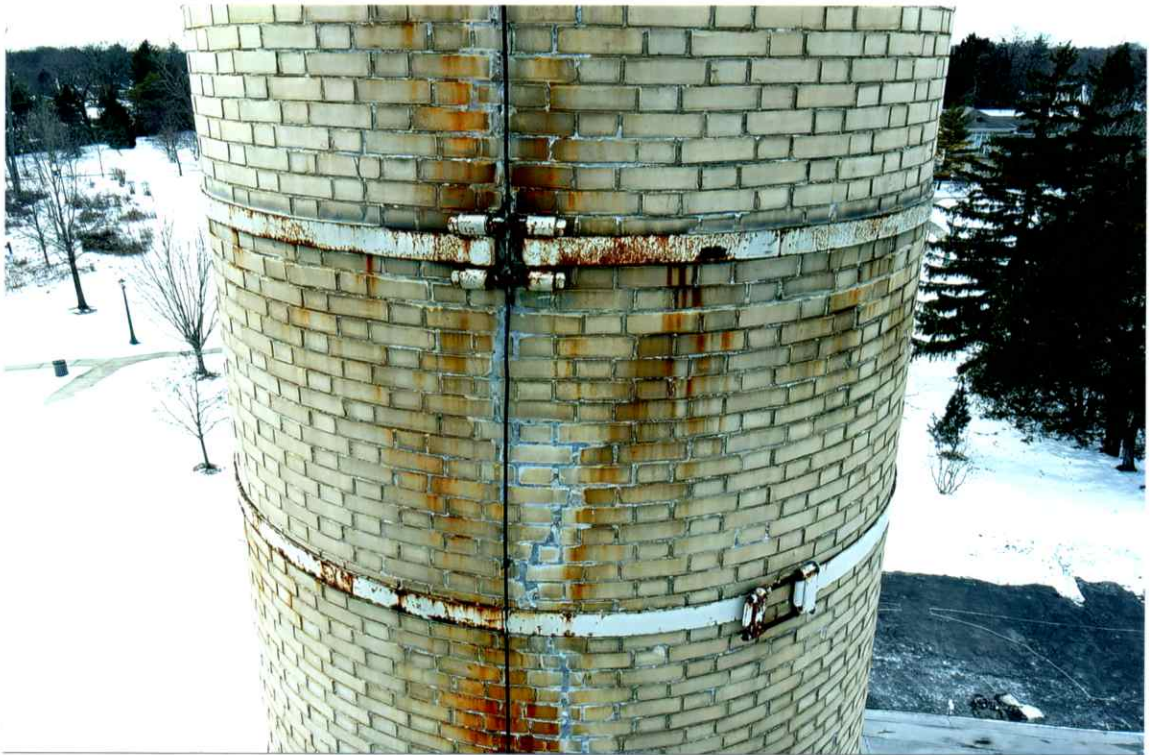
Photo 47. Good exterior condition of the east side local to the 56' level. Mortar joints were only slightly weathered. Repairs to the crack were sound.

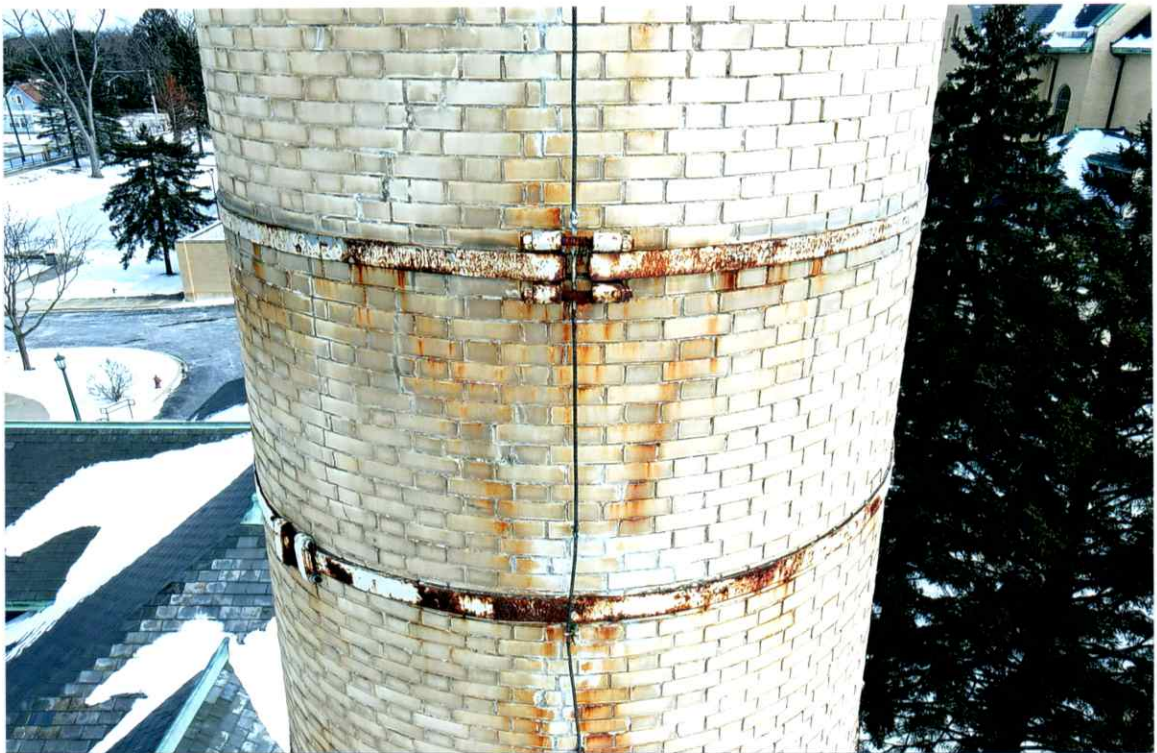
Photo 48. Good exterior condition of the west side local to the 56' level. Mortar joints were only slightly weathered. Repairs to the crack were sound.

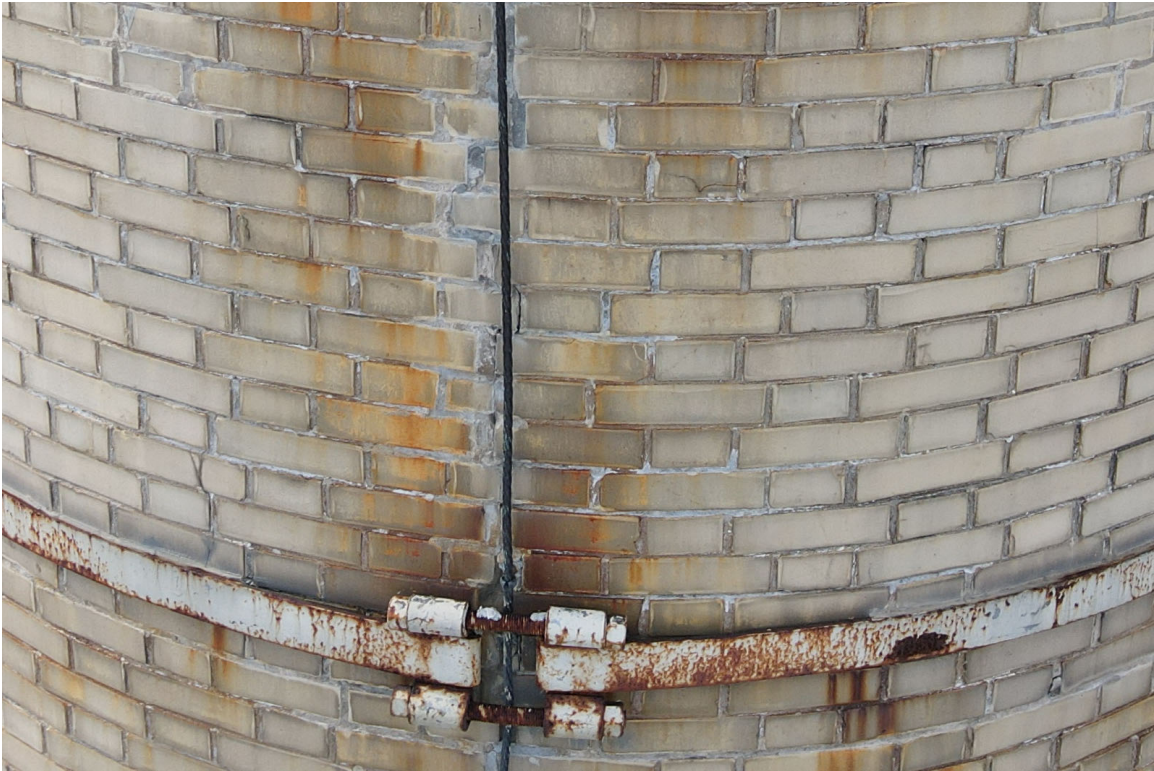
Photo 49. Close-up of the good condition of the repaired crack (east side, 61' level).

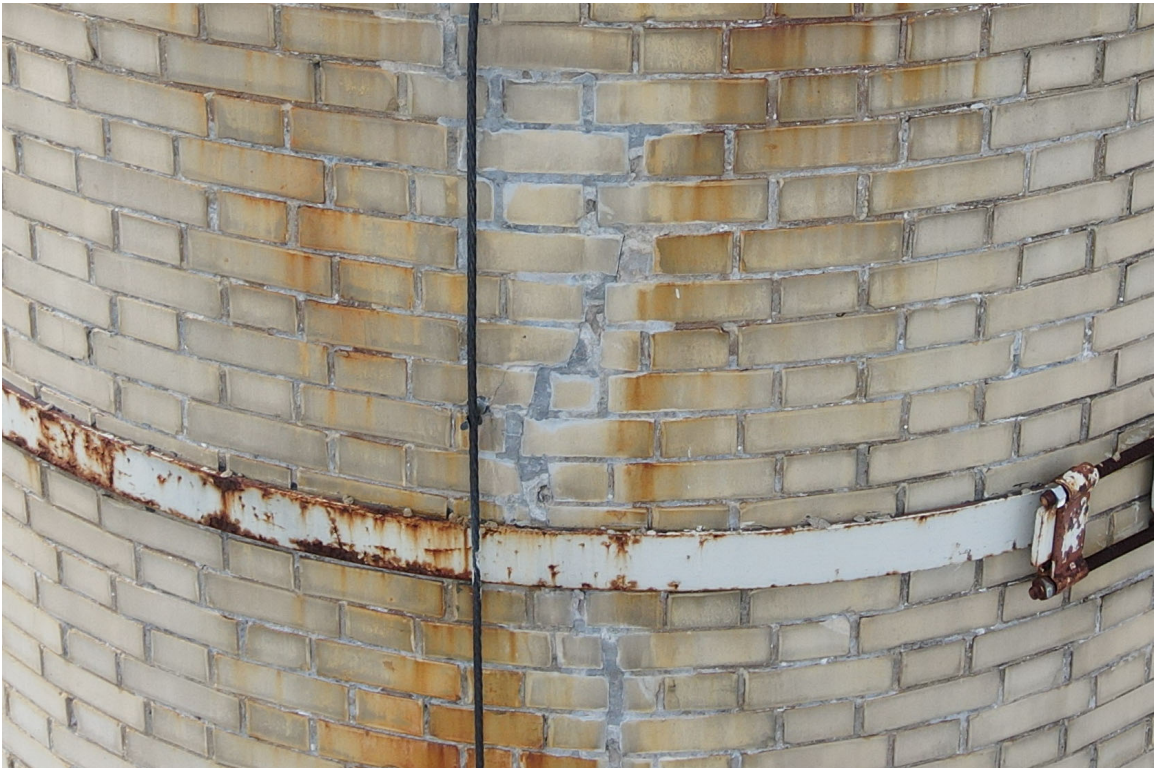
Photo 50. Close-up of the good condition of the repaired crack (east side, 56' level).

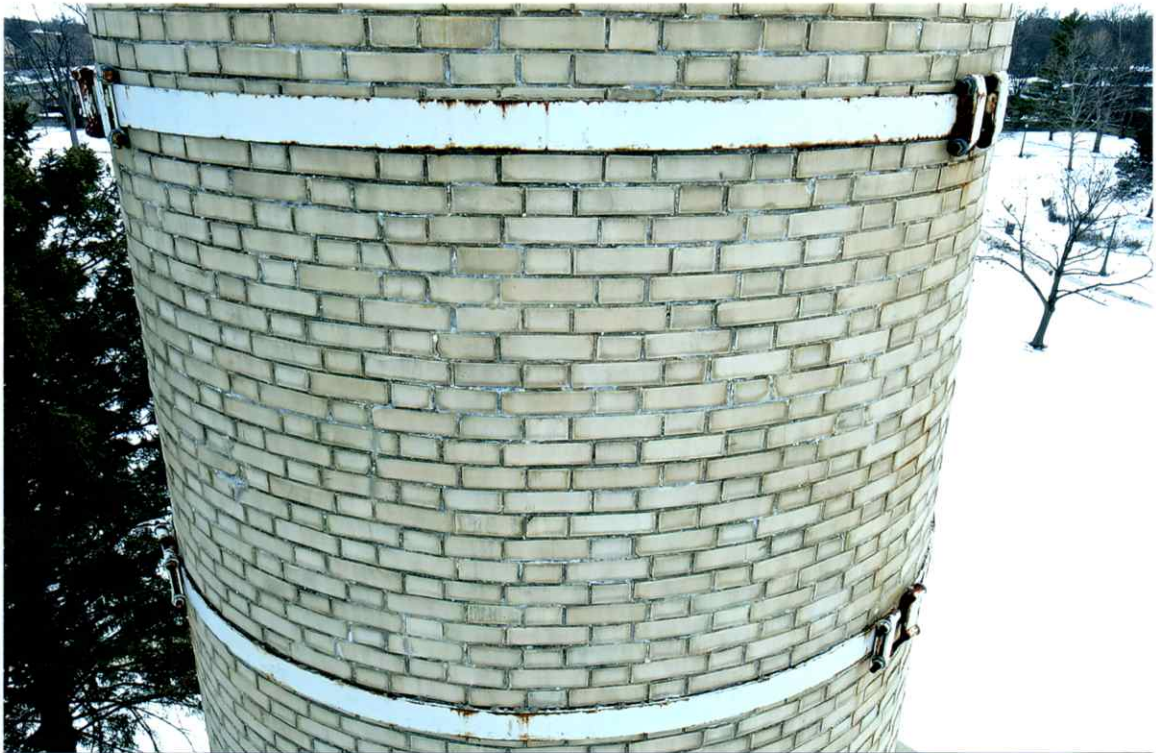
Photo 51. Good exterior condition of the north side local to the 50' level. Mortar joints were only slightly weathered. All bands were secure.

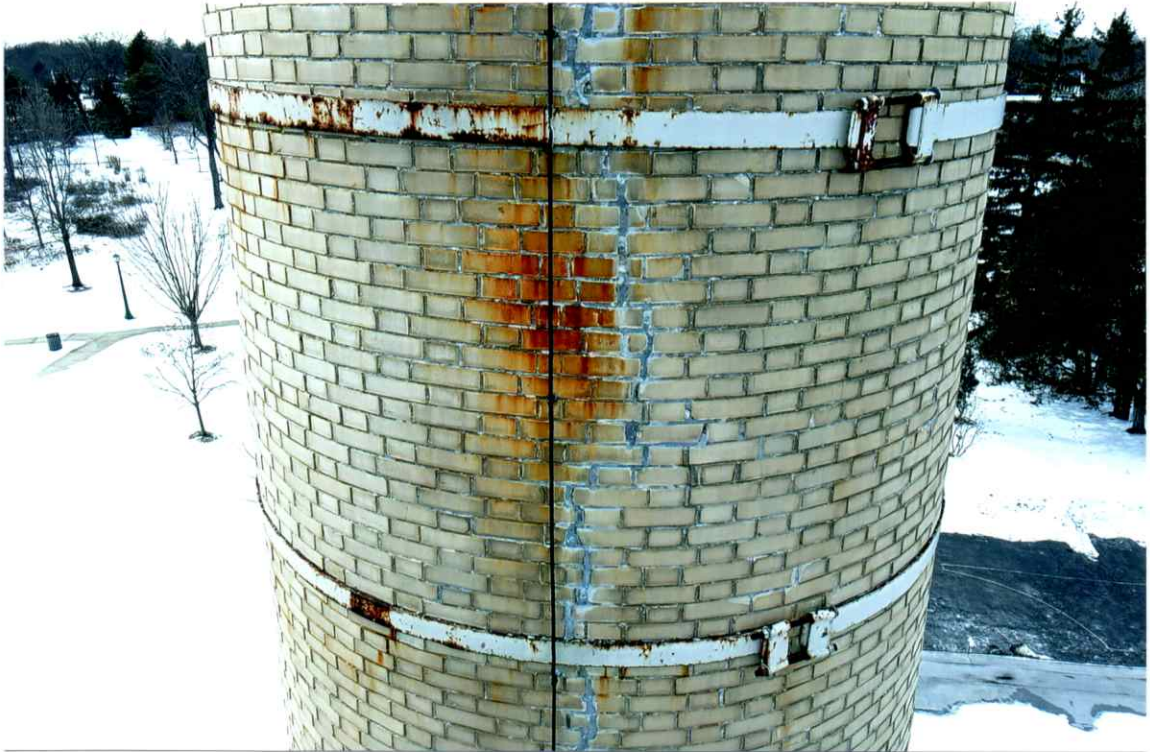
Photo 53. Good exterior condition of the east side local to the 50' level. Mortar joints were only slightly weathered. Repairs to the crack were sound (see Photo 59).

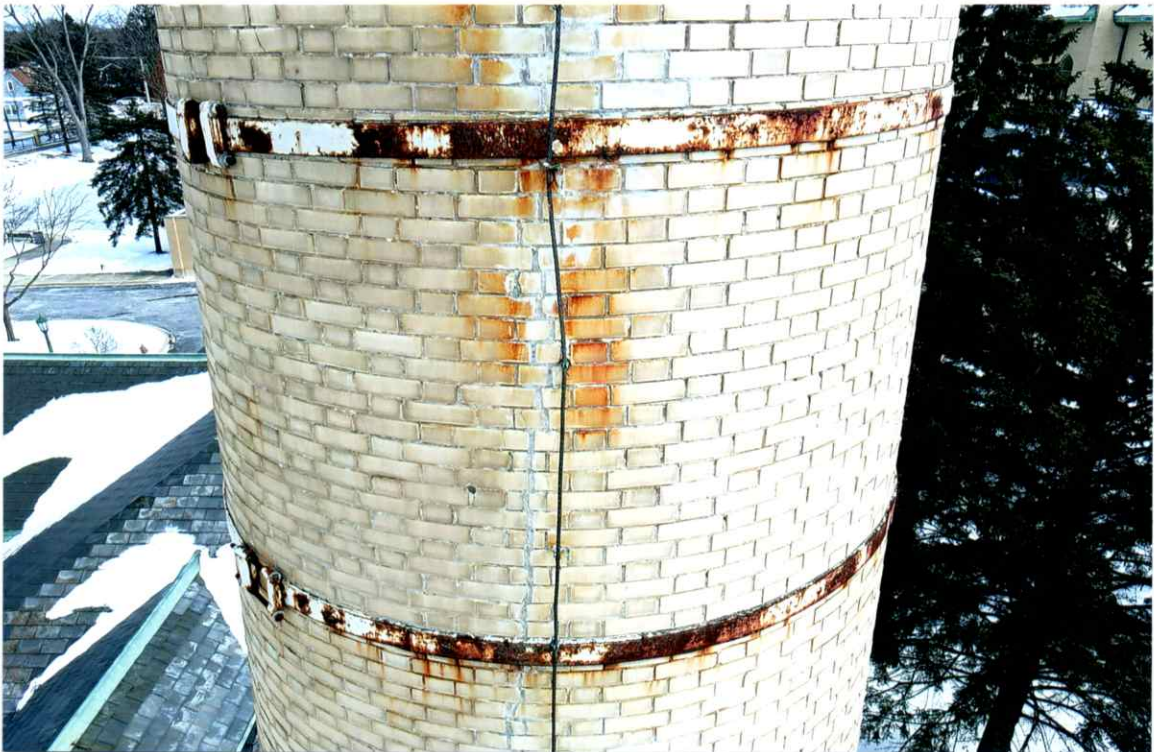
Photo 54. Good exterior condition of the west side local to the 50' level. Mortar joints were only slightly weathered. Repairs to the crack were sound.

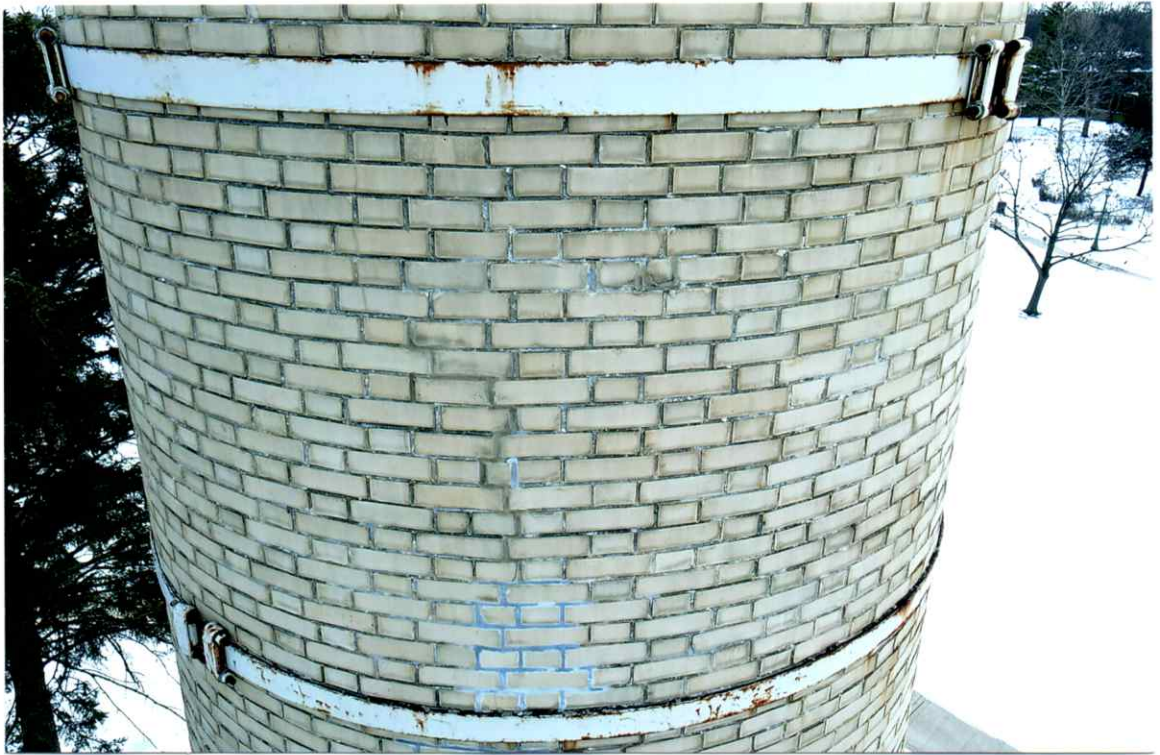
Photo 55. Good exterior condition of the north side local to the 44' level. Mortar joints were only slightly weathered. Repairs to the crack were sound.

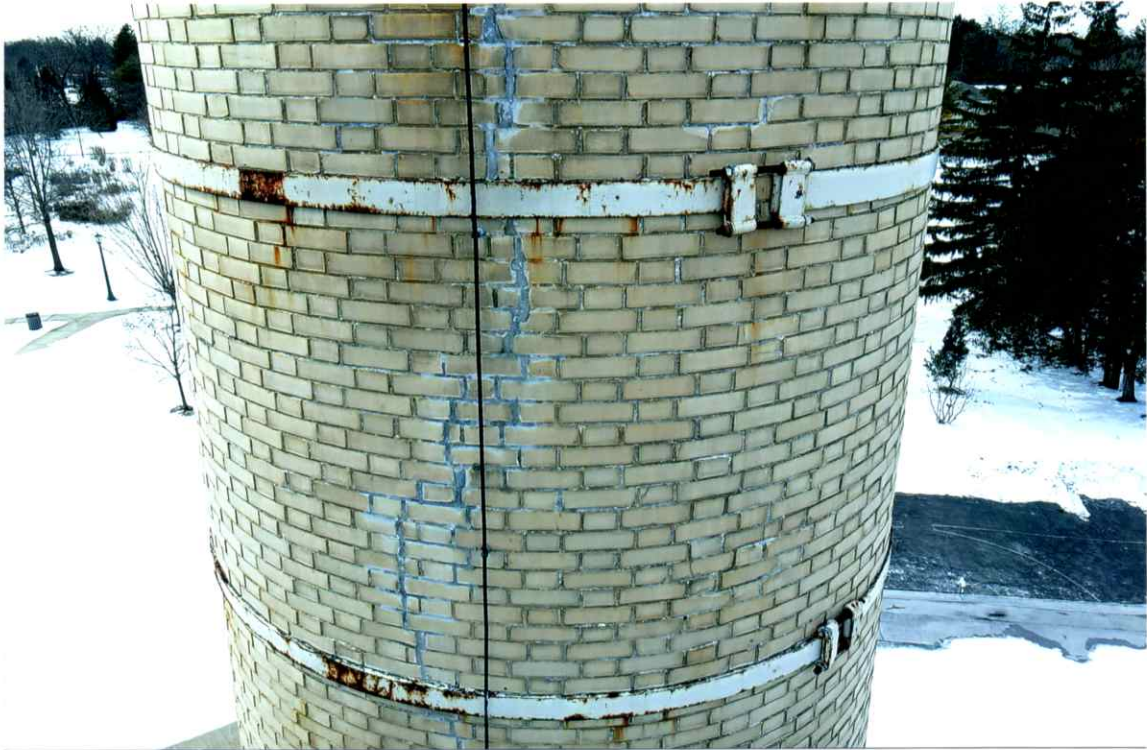
Photo 57. Good exterior condition of the east side local to the 44' level. Mortar joints were only slightly weathered. Repairs to the crack were sound (see Photo 60).

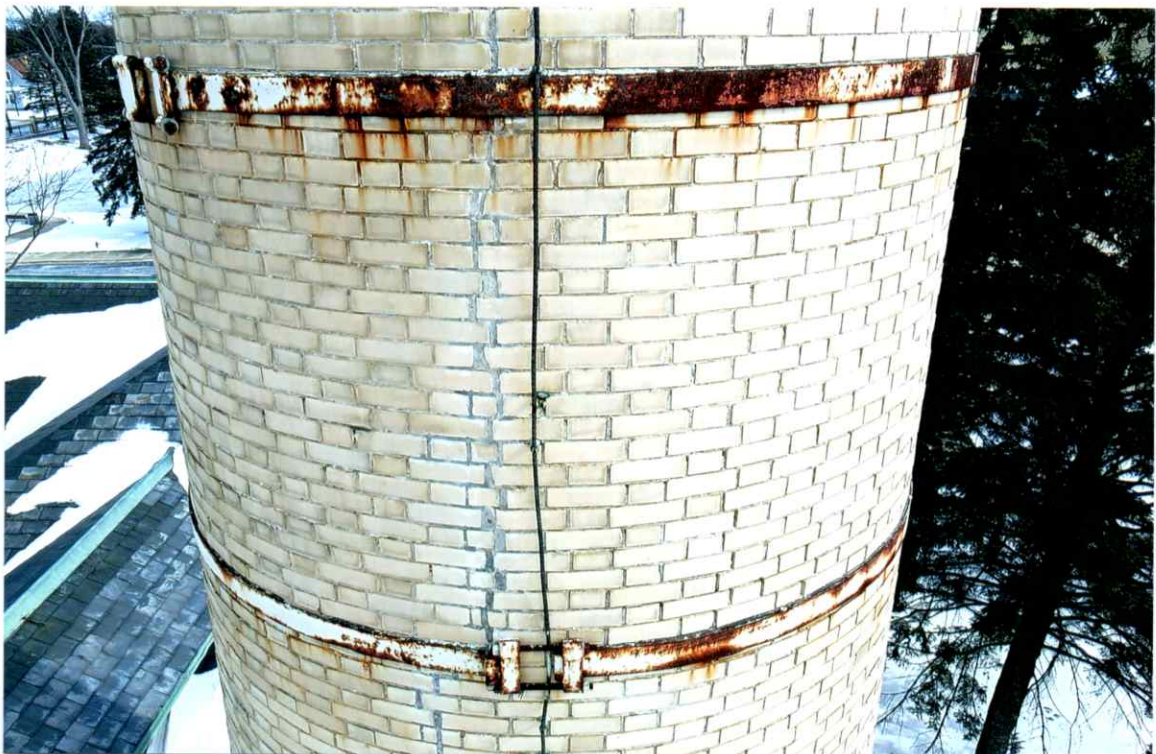
Photo 58. Good exterior condition of the west side local to the 44' level. Mortar joints were only slightly weathered. Repairs to the crack were sound.

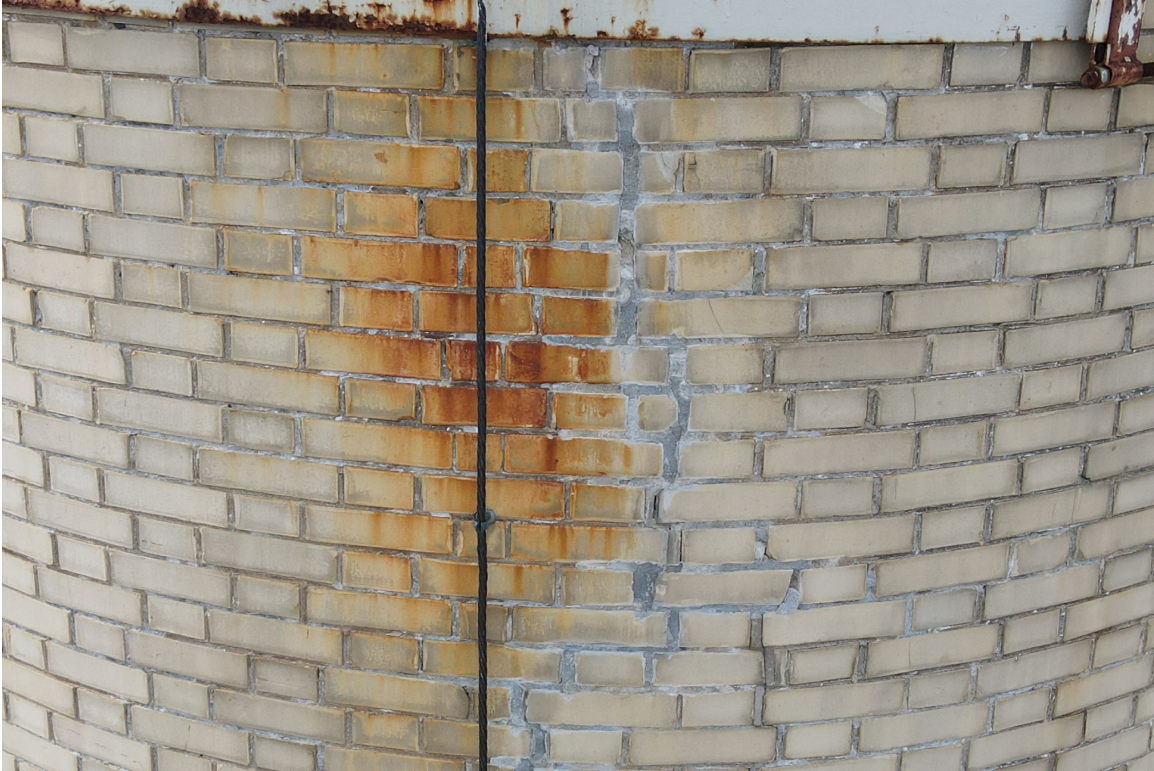
Photo 59. Close-up of the good condition of the repaired crack (east side, 50' level).

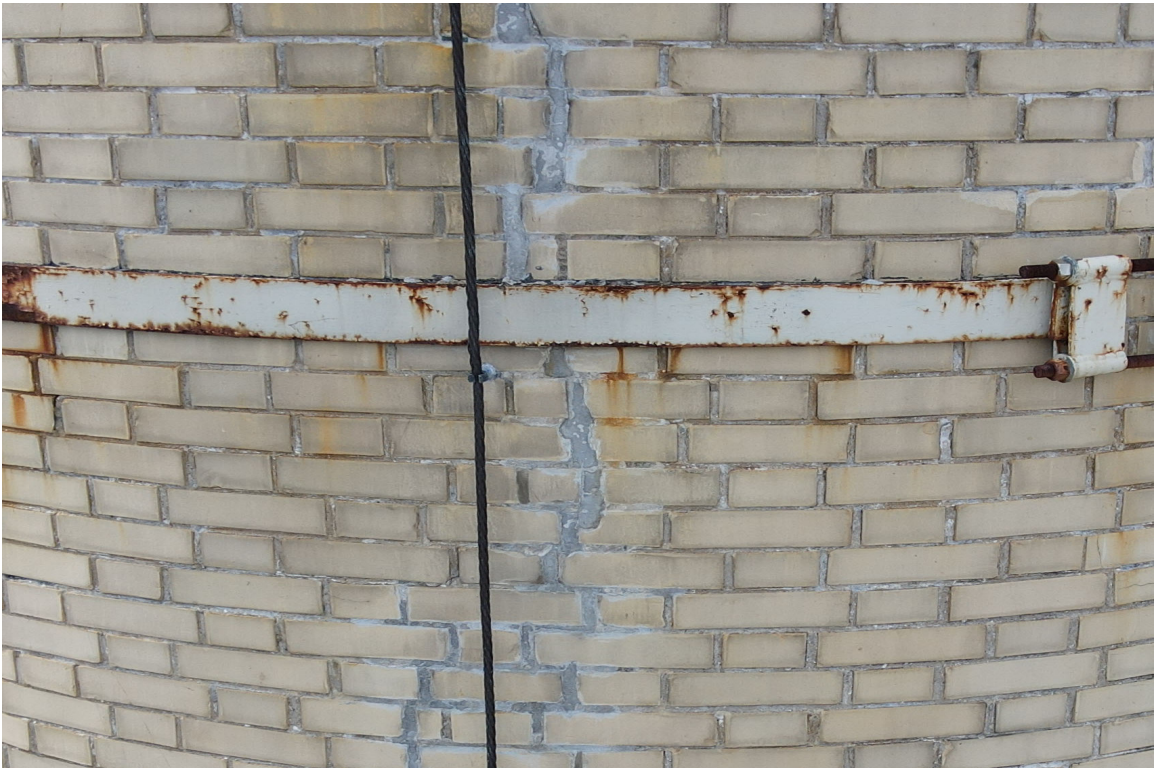
Photo 60. Close-up of the good condition of the repaired crack (east side, 44' level).

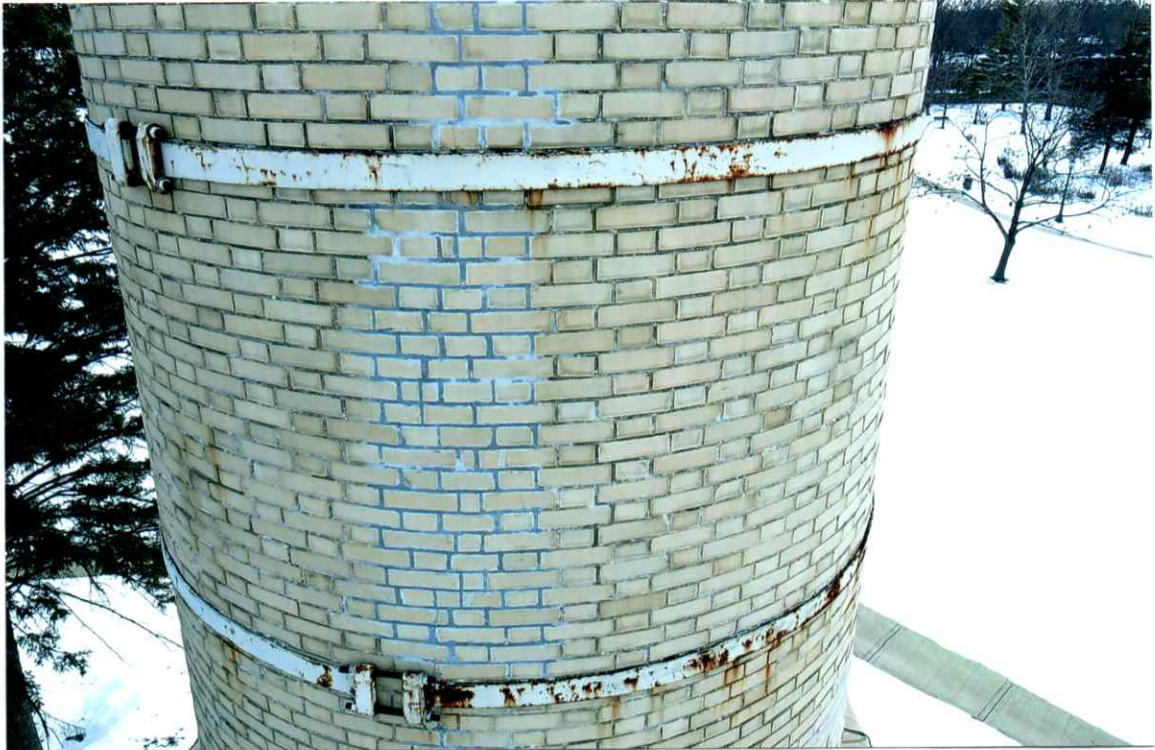
Photo 61. Good exterior condition of the north side local to the 38' level. Mortar joints were only slightly weathered. Note the rust on the bands.

- The exterior surface of the steel tension bands will be cleaned of peeling paint and loose rust. The prepared steel bands will be coated with a rust inhibitive industrial grade product. Sealant will be installed at the top edge of each band to prevent moisture infiltration between the band and the chimney.
