**Wilmette Park District
Mallinckrodt Chimney
Masonry Repairs**

**INVITATION TO BID 2026
Mallinckrodt Chimney
Masonry Repair
WILMETTE PARK DISTRICT**

The Wilmette Park District is seeking sealed base bids for masonry repairs to the chimney that sits on 1929 Elmwood AVE Wilmette , IL 60091 located at our Mallinckrodt facility. Currently, the chimney houses Verizon Wireless telecommunications equipment.

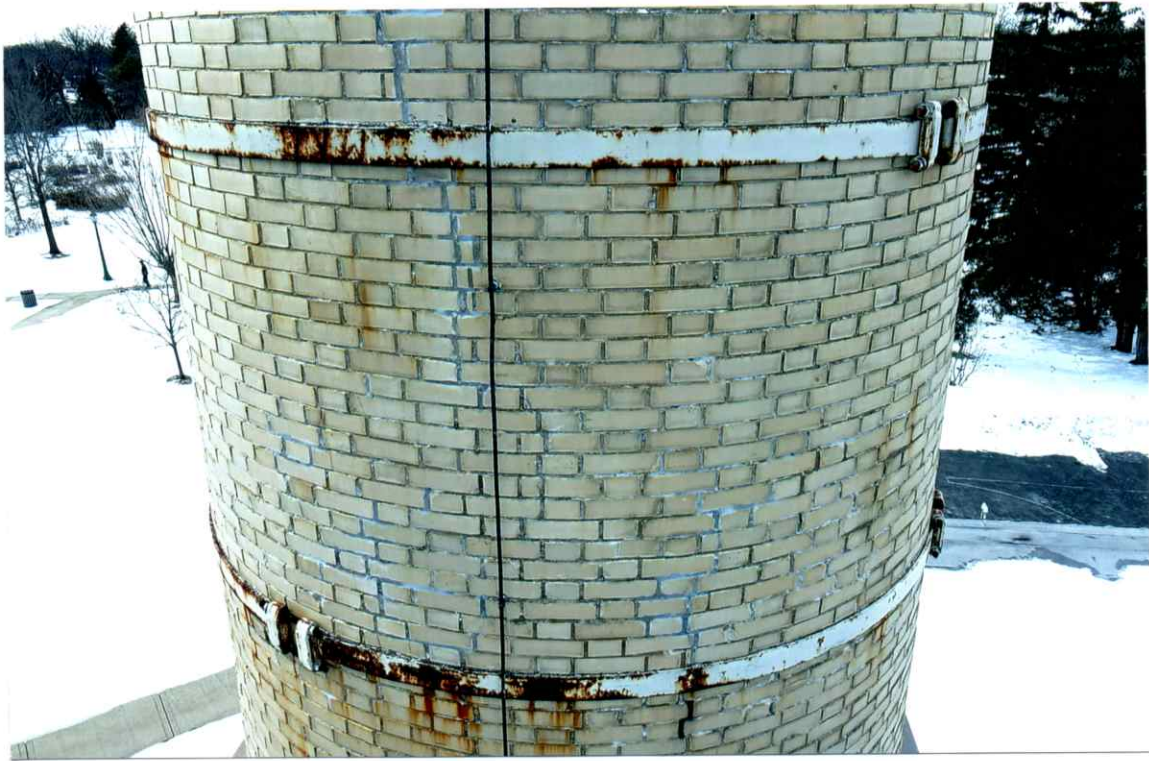
Photo 63. Good exterior condition of the east side local to the 38' level. Mortar joints were only slightly weathered. Note the rust on the bands.

- The exterior surface of the steel tension bands will be cleaned of peeling paint and loose rust. The prepared steel bands will be coated with a rust inhibitive industrial grade product. Sealant will be installed at the top edge of each band to prevent moisture infiltration between the band and the chimney.

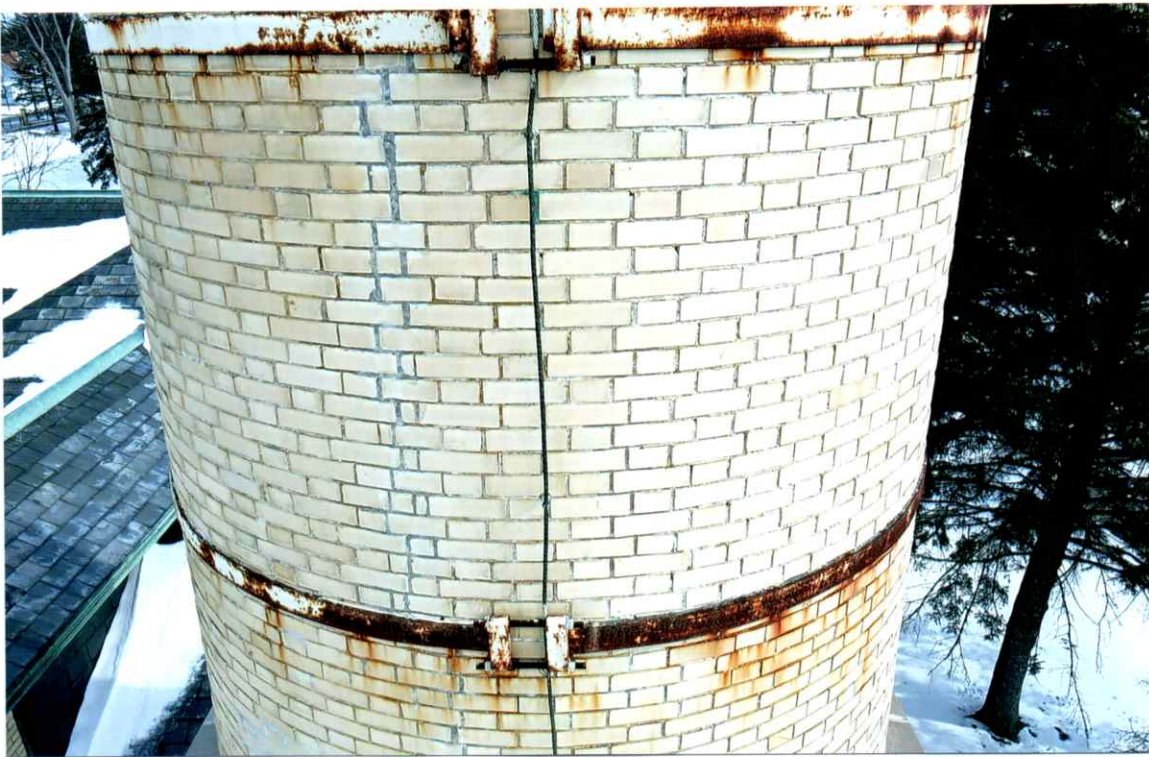
Photo 64. Good exterior condition of the west side local to the 38' level. Mortar joints were only slightly weathered. Note the rust on the bands.

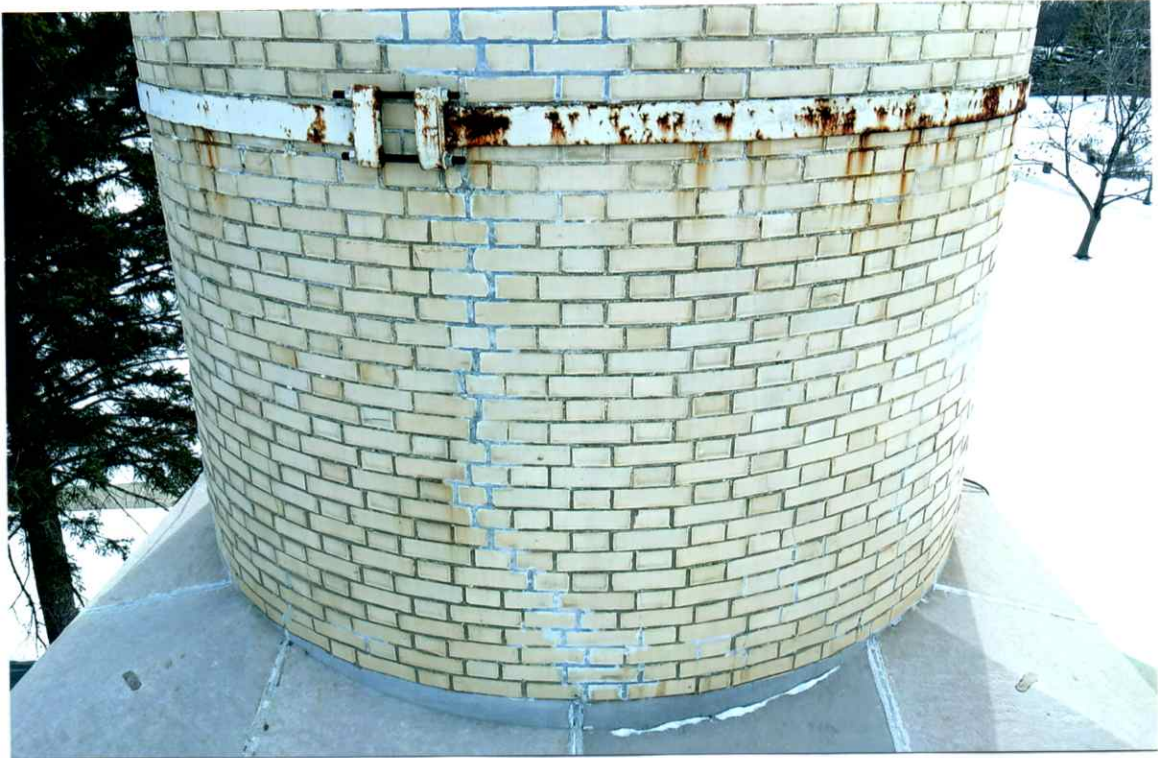
Photo 65. Good exterior condition of the north side local to the 32' level. Mortar joints were only slightly weathered. Repairs to the crack were sound.

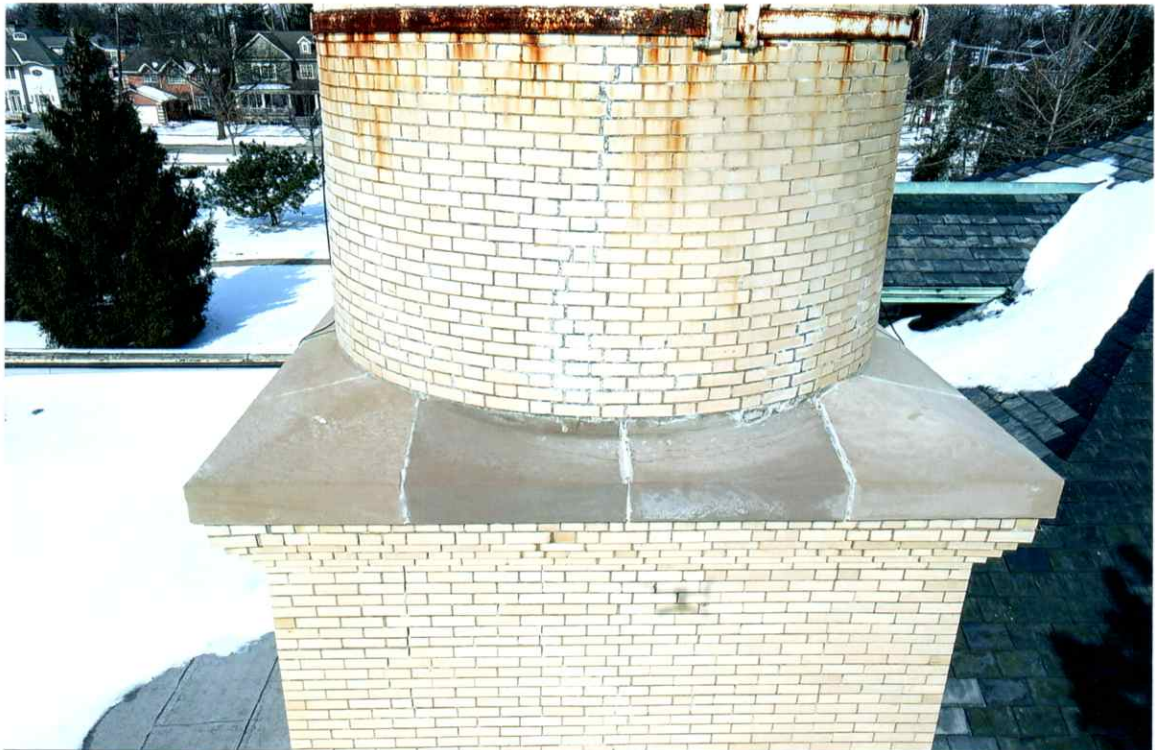
Photo 66. Good exterior condition of the south side local to the 32' level. Mortar joints were only slightly weathered. Repairs to the crack were sound.

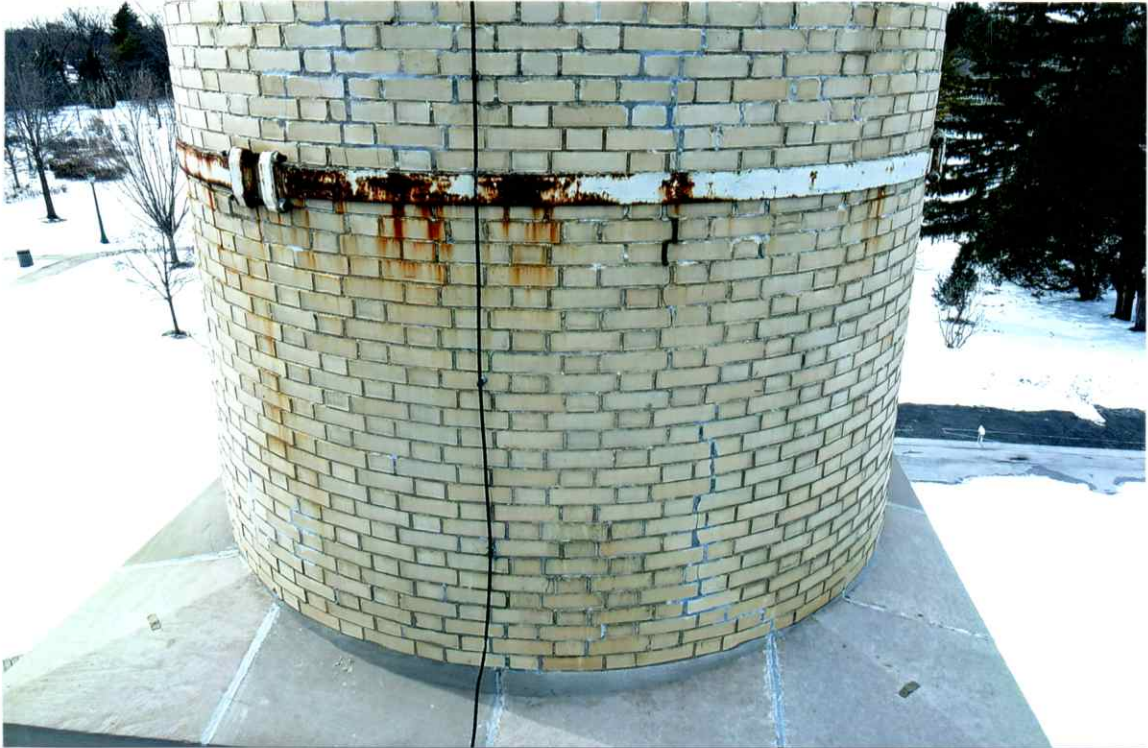
Photo 67. Good exterior condition of the east side local to the 32' level. Mortar joints were only slightly weathered. Repairs to the cracks were sound.

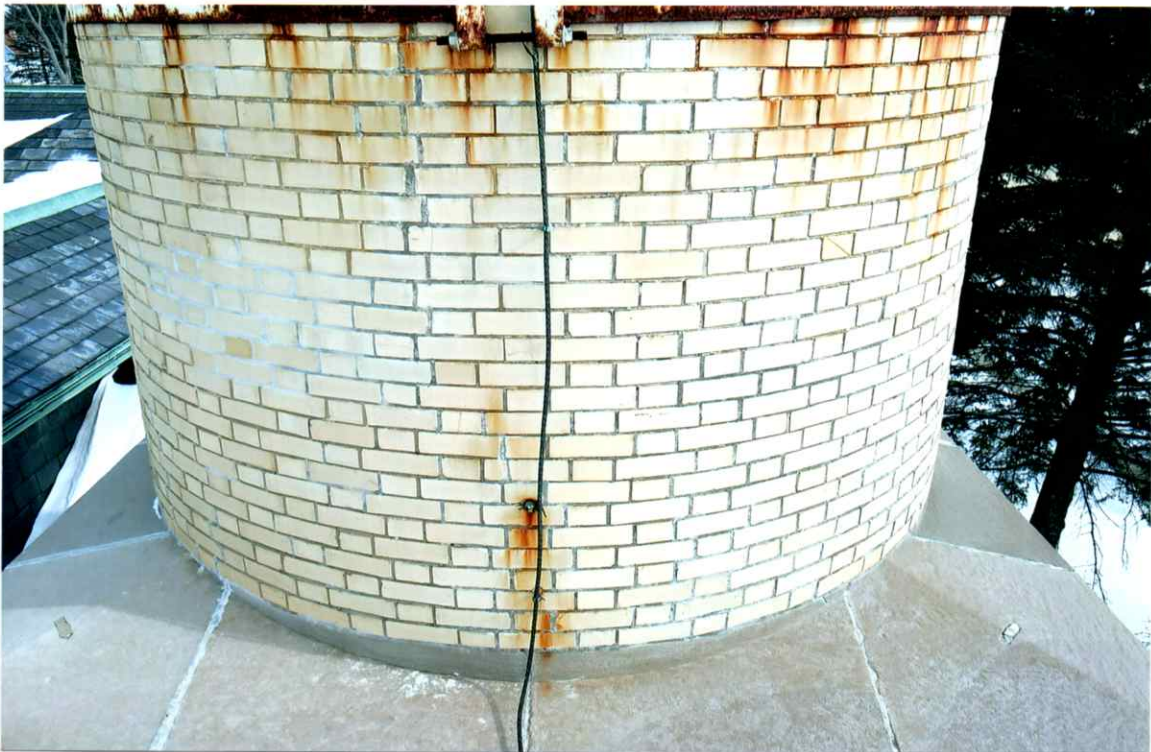
Photo 68. Good exterior condition of the west side local to the 32' level. Mortar joints were only slightly weathered.

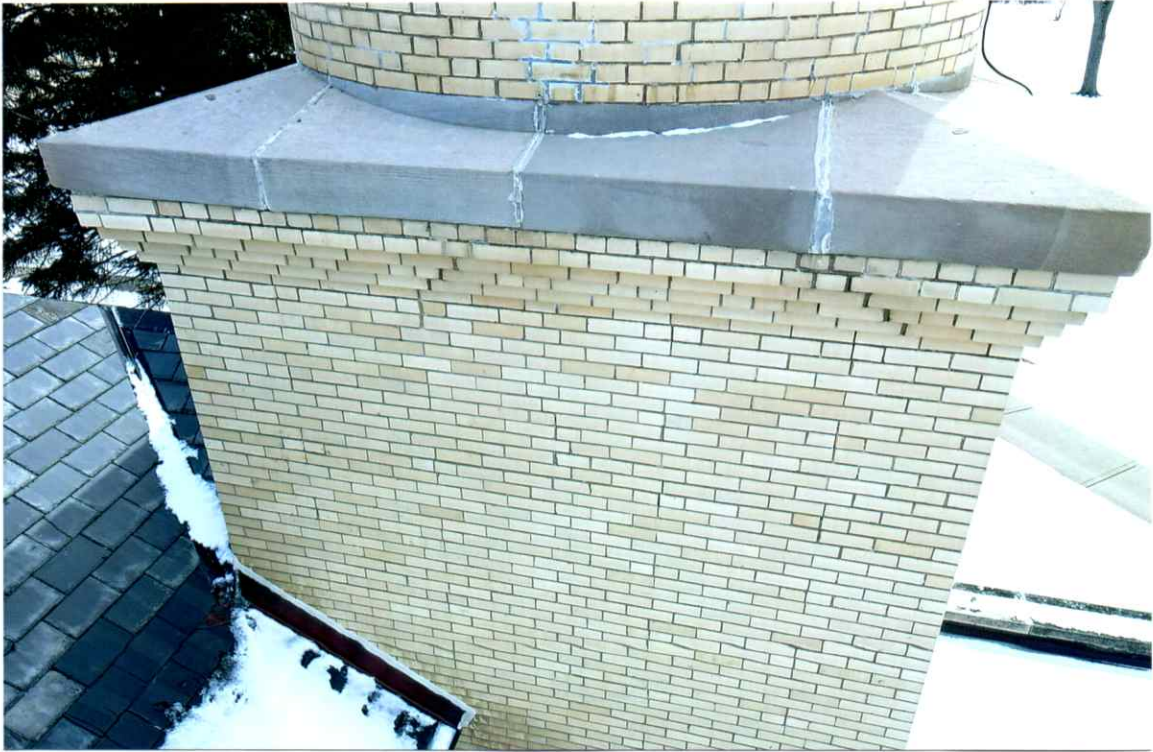
Photo 69. Good condition of the stone transition and corbelled square regions (29' level, north side). A few open and recessed mortar joints were observed.

- The open and deteriorated mortar joints below the 70'-0 level (approx. 10% / 200 SF) will be ground out as needed and the prepared mortar joints will be tuckpointed with an ASTM C270 Type N mortar. The joints will be rinsed of dust and debris prior to repointing.

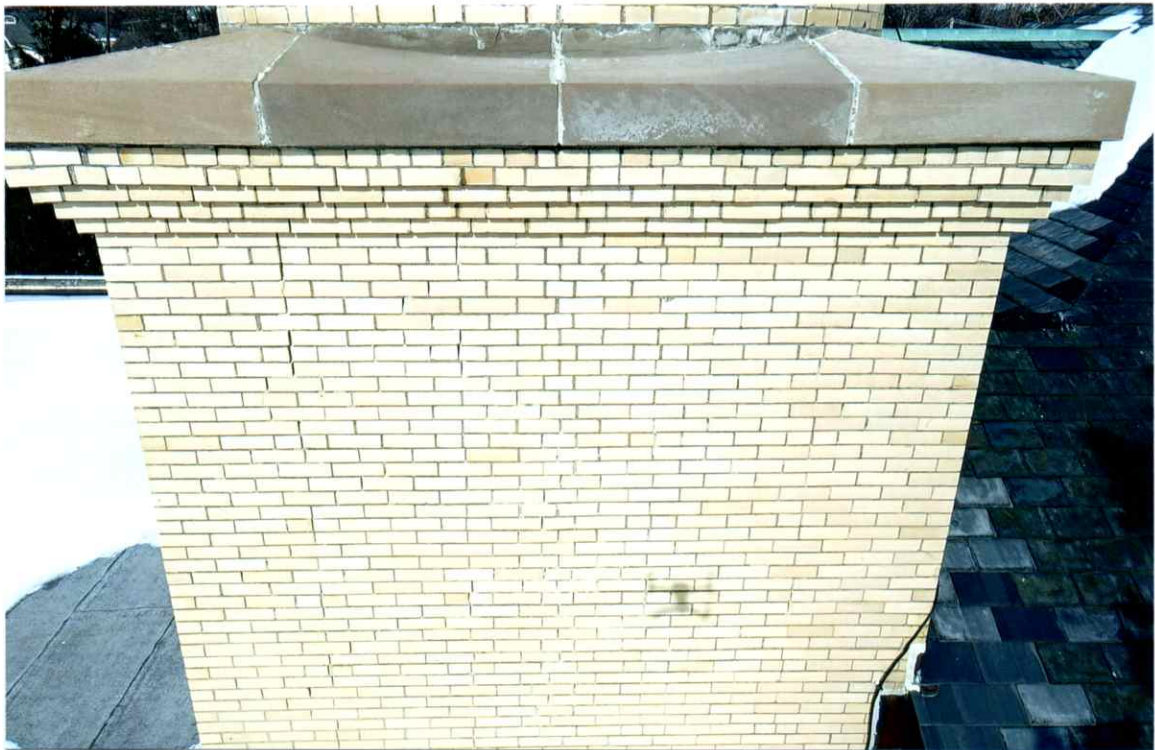
Photo 70. Good condition of the stone transition and corbelled square regions (29' level, south side). A few open and recessed mortar joints were observed.

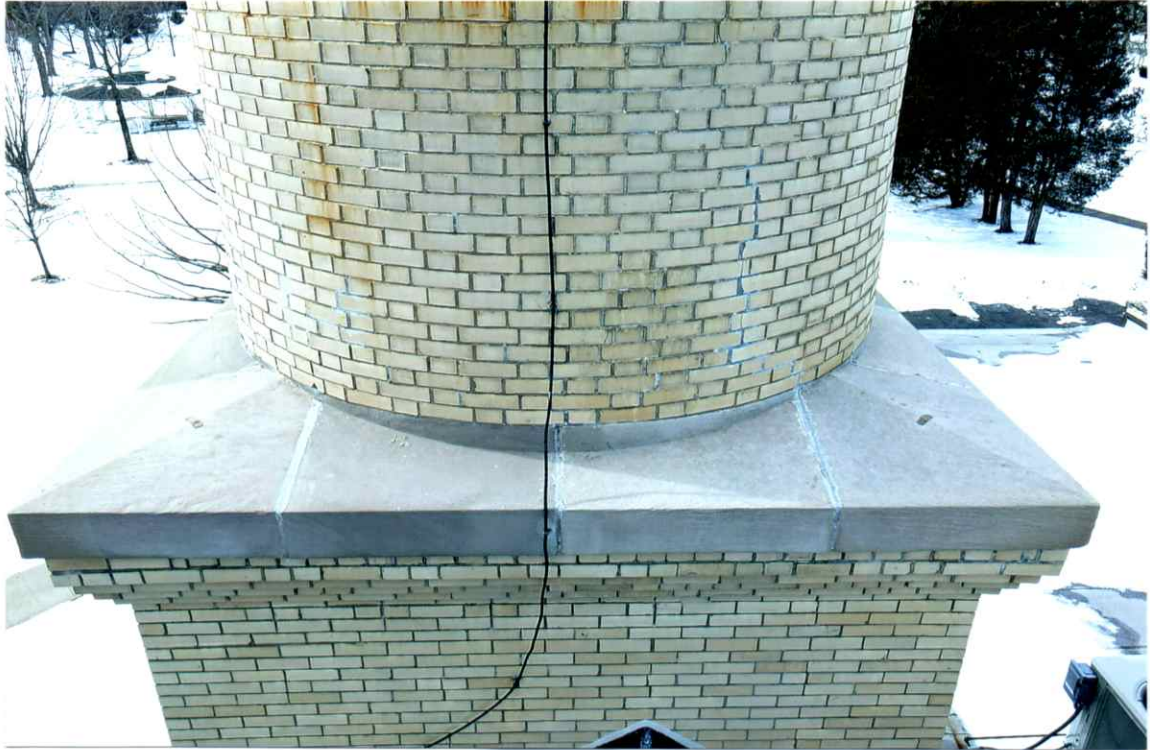
Photo 71. Good condition of the stone transition and corbelled square regions (29' level, east side). A few open and recessed mortar joints were observed.

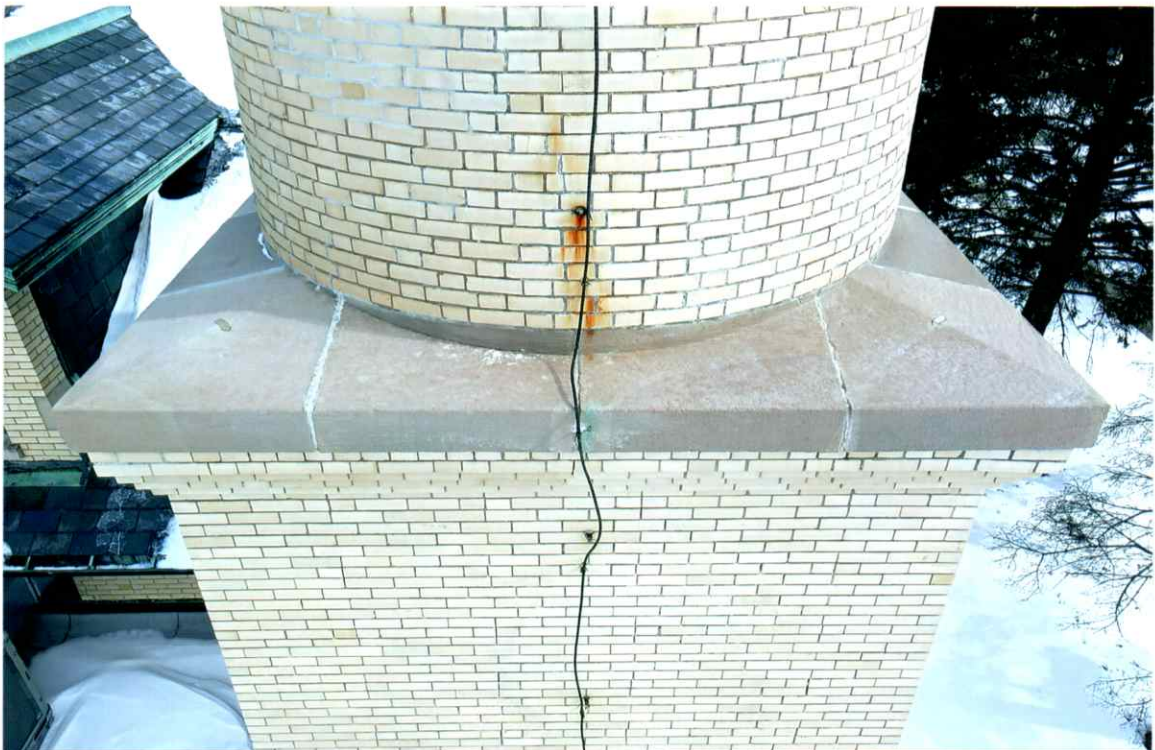
Photo 72. Good condition of the stone transition and corbelled square regions (29' level, west side). A few open and recessed mortar joints were observed.

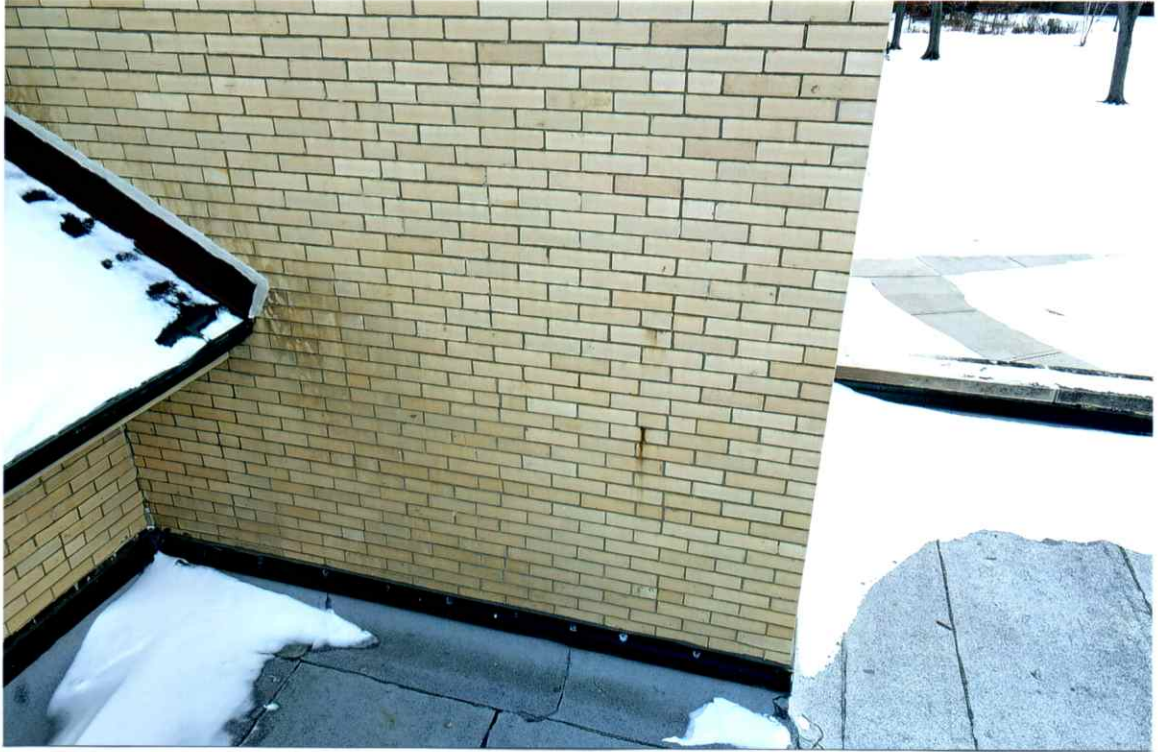
Photo 73. Good condition of the square region above the building roof (north side).

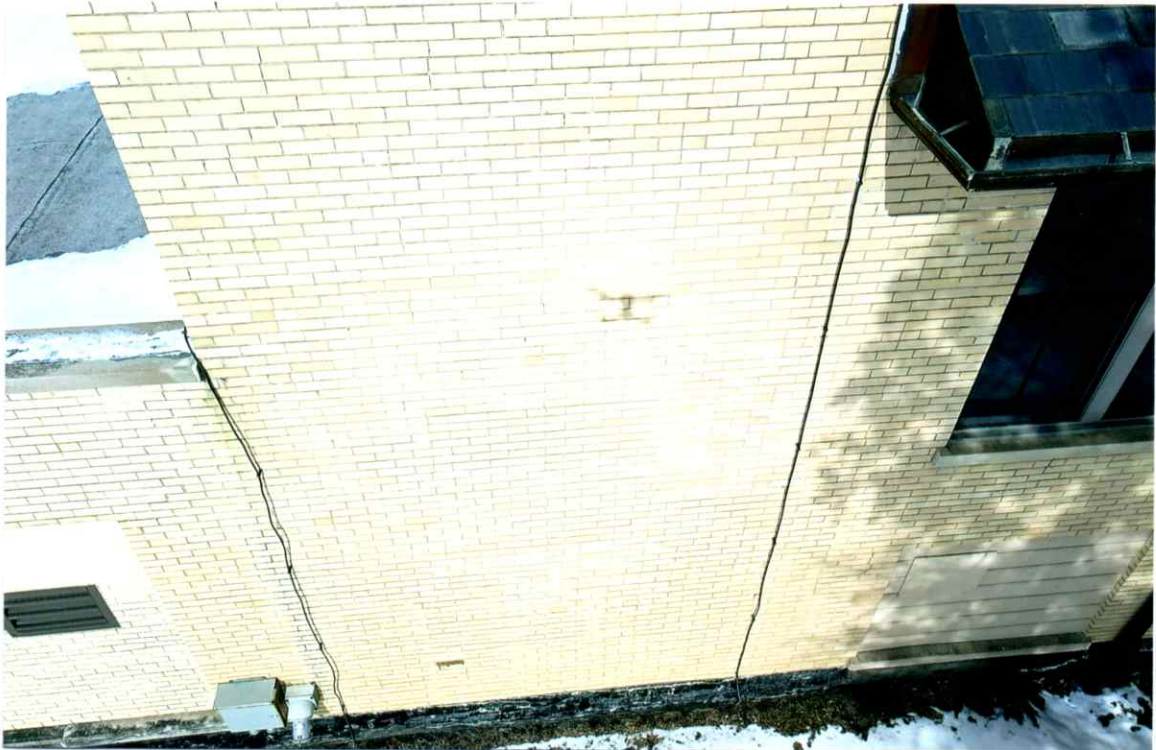
Photo 74. Good condition of the square region in the 25' region above grade (south side). Both LPS downlead cables were properly grounded at grade.

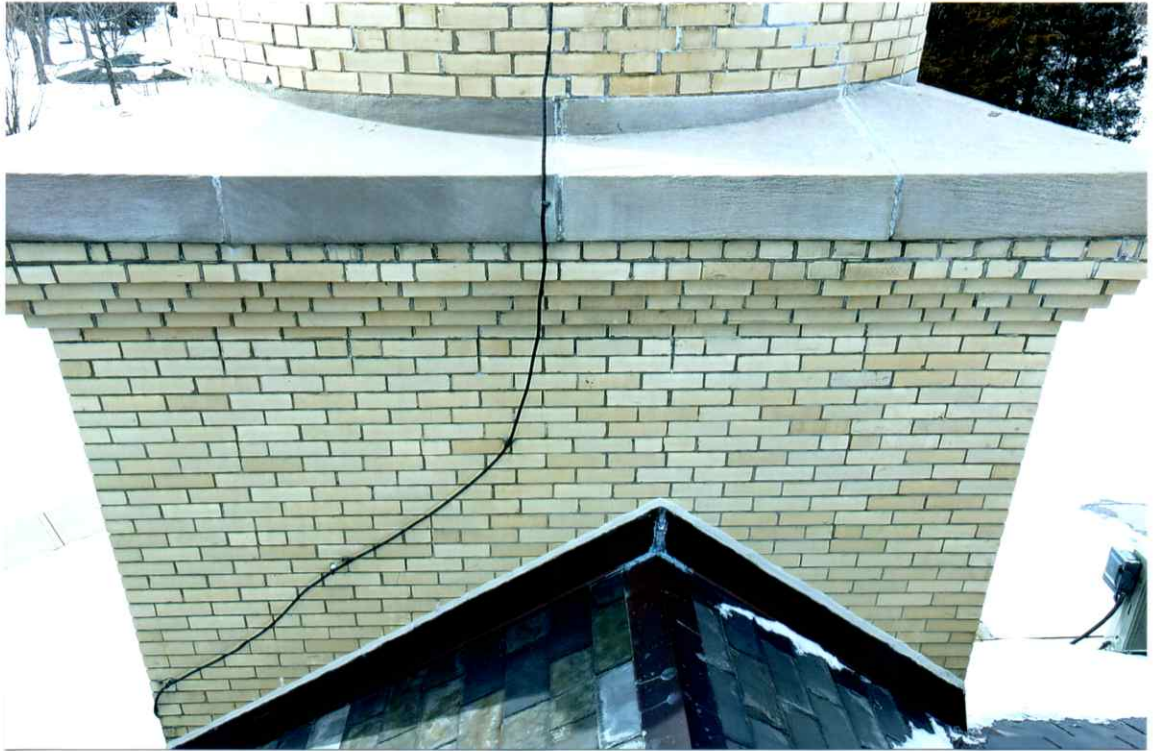
Photo 75. Good condition of the square region above the building roof (east side).

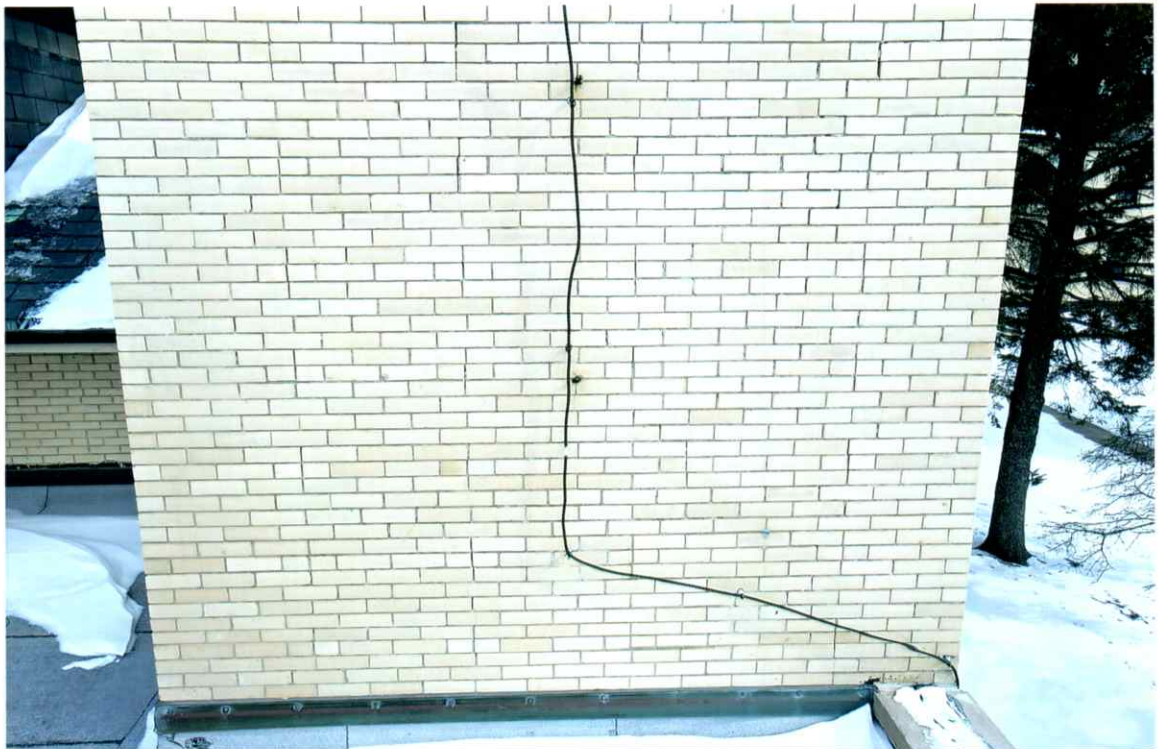
Photo 76. Good condition of the square region above the building roof (west side).

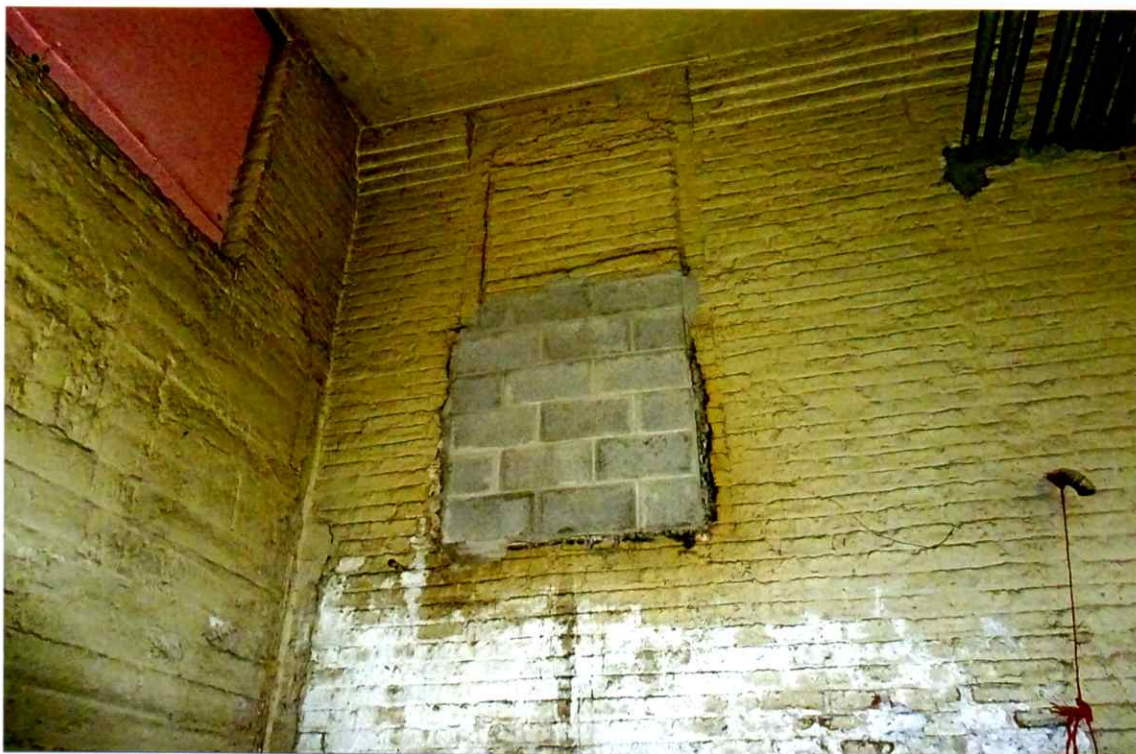
Exposed brick faces and mortar joints in the boiler room (lower west wall) appeared in fair condition (Photos 77 - 78). Brick and block installed in the duct opening remained sound. The wall at to the cleanout door also appeared sound (Photos 79 - 80).

Photo 77. Good condition of the bricked and blocked up boiler duct opening (east side, sill near grade).

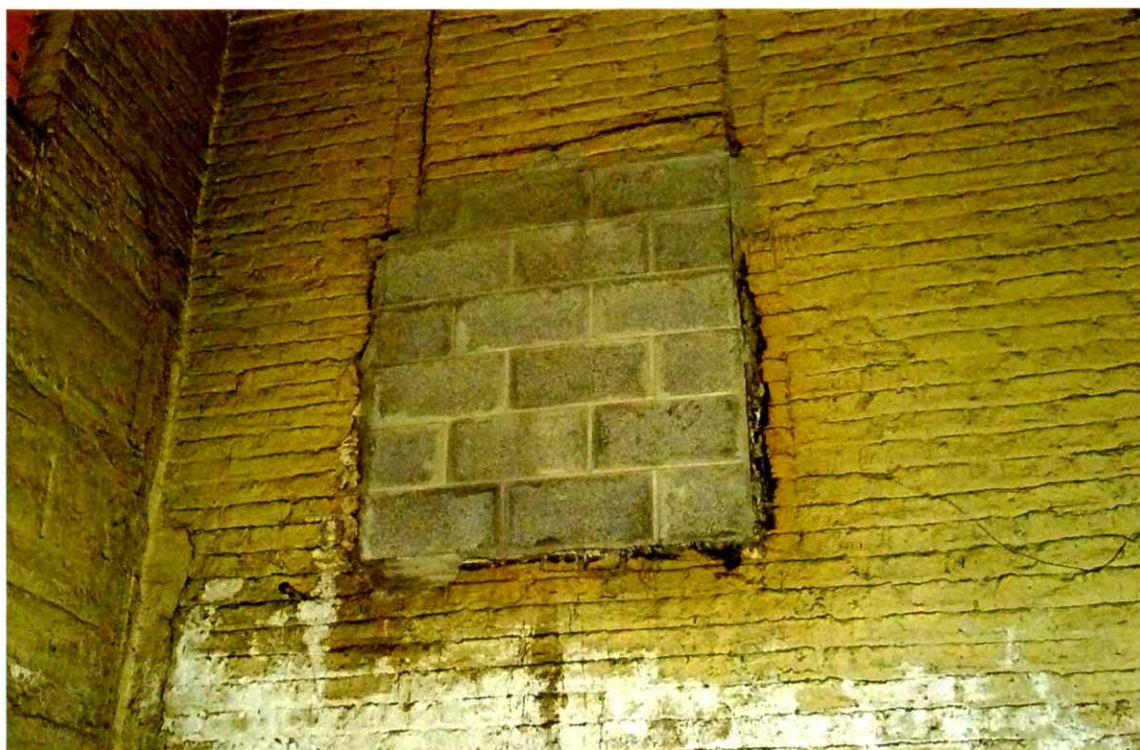
The original boiler duct had been previously removed from the chimney and the opening either bricked or blocked up (Photos 77 - 78). No concerns were noted with the materials enclosing the original opening.

Photo 78. Close-up of the blocked up boiler duct opening (east side, sill near grade).

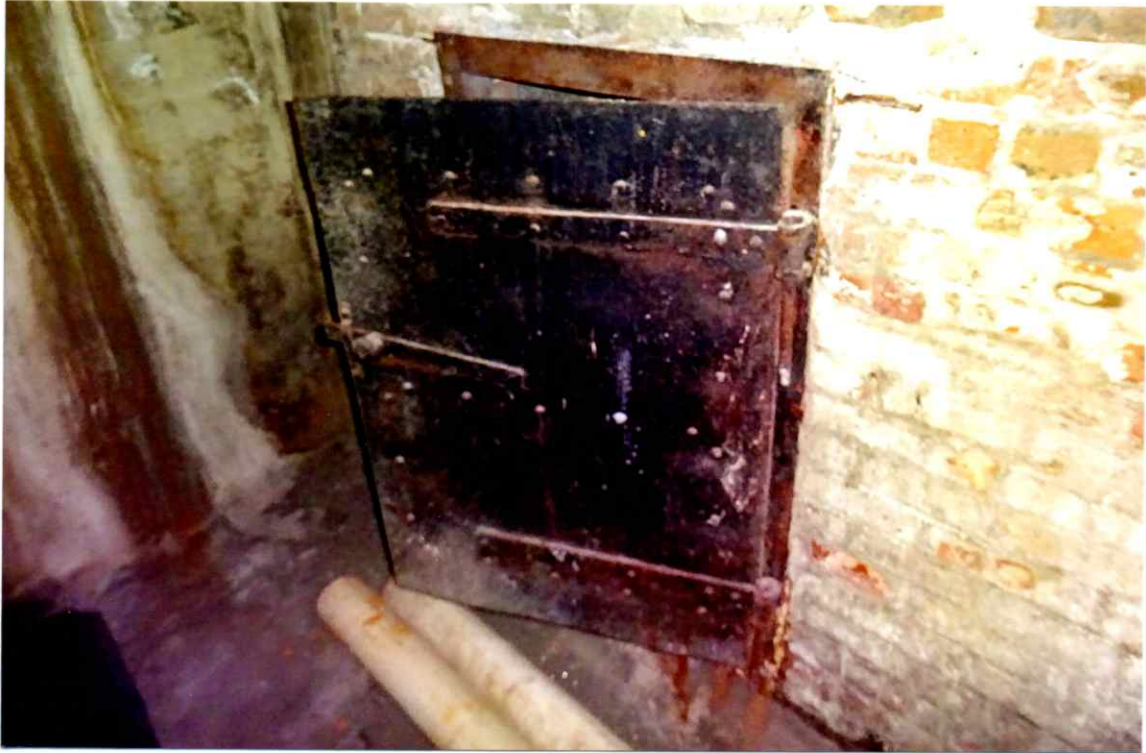
Photo 79. Good exterior condition of the cleanout door at the base of the east wall.

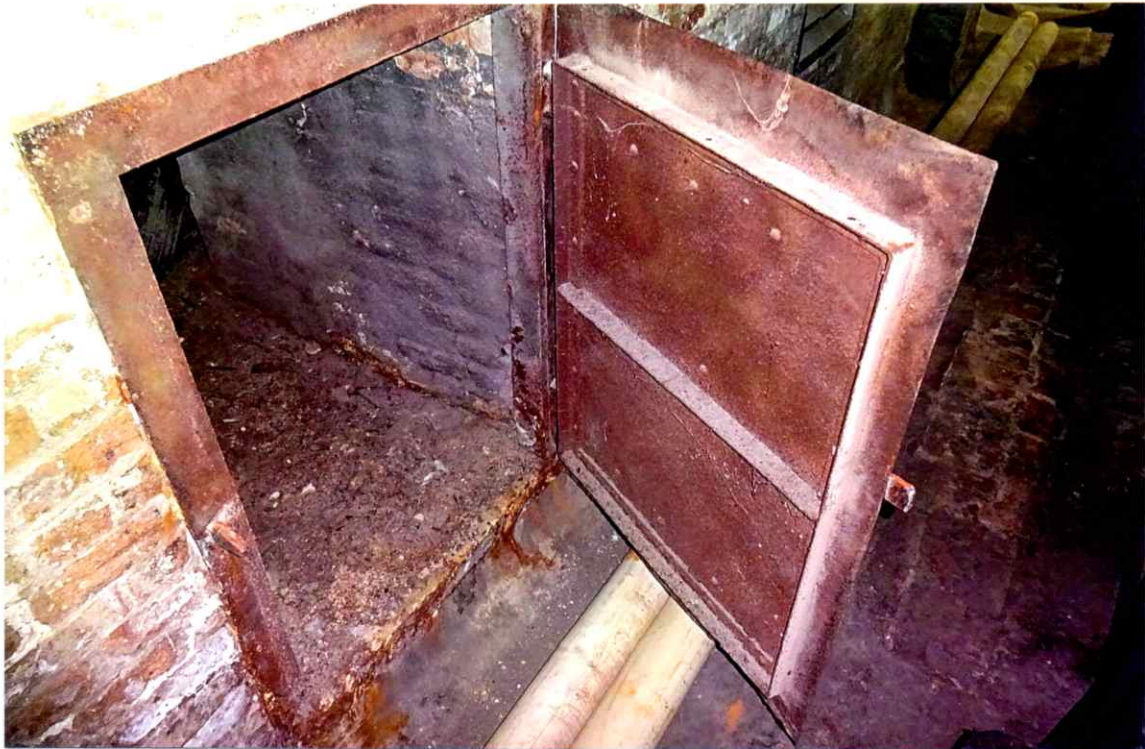
The steel cleanout door at the base of the east side remained in good condition. Exterior surfaces of the door were painted. The door frame and interior surfaces possessed only light surface rust. No holes or severely deteriorated areas were identified. The hinges and latch were also in good working condition. Photos 79 - 80 show the door.

Photo 80. Fair interior condition of the cleanout door at the base of the east wall.

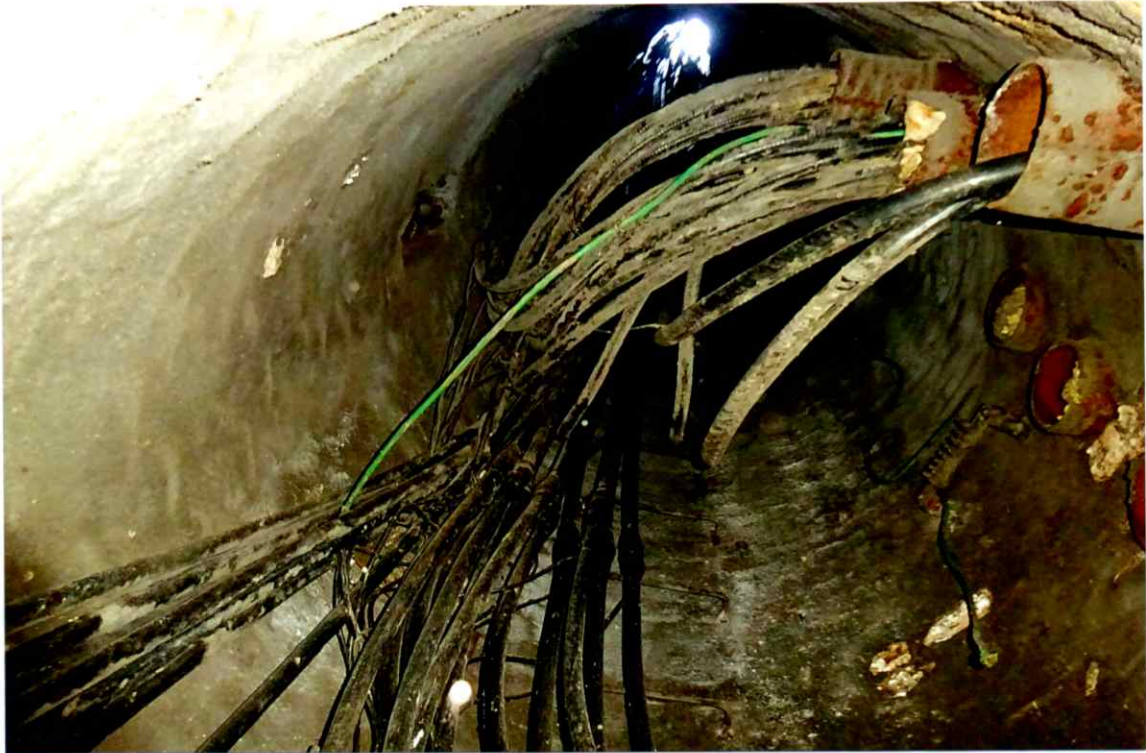
Photo 81. Good interior condition of the lower elevations looking up from the base. Note the numerous coaxial cables traversing up the chimney.

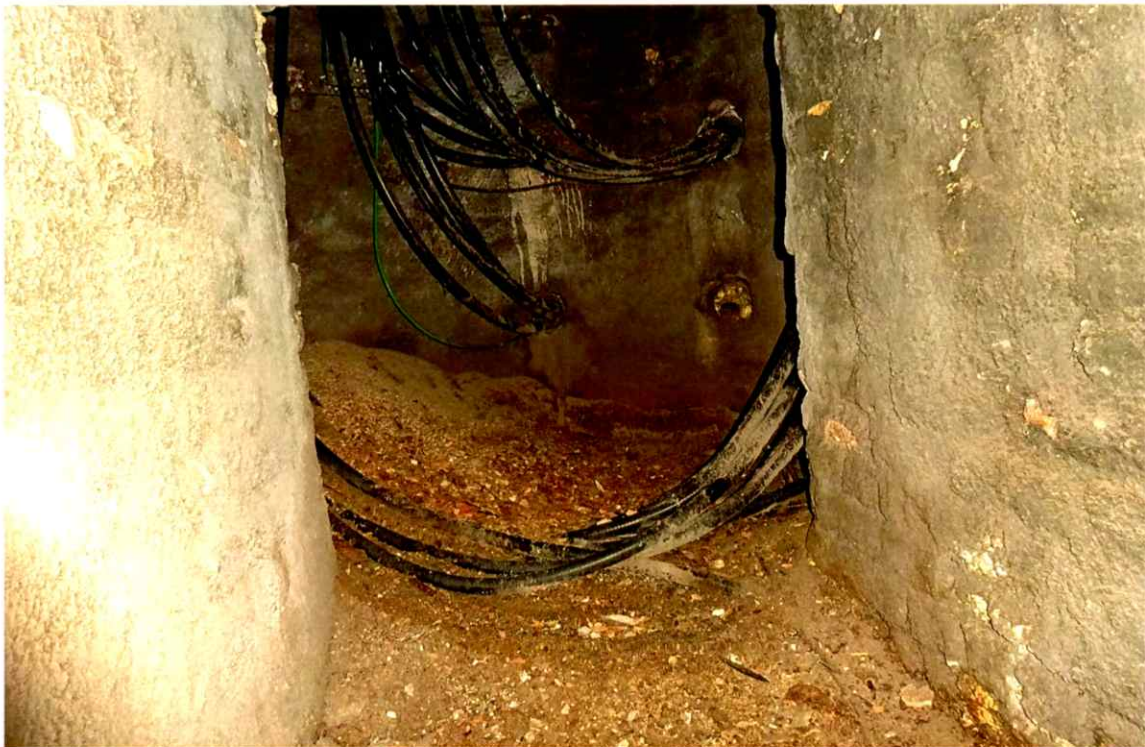
When viewed from the cleanout door, interior surfaces throughout the lower elevations appeared in good condition (Photo 81). The floor of the chimney possessed approximately 8" of accumulated ash and debris (Photos 83 – 84).

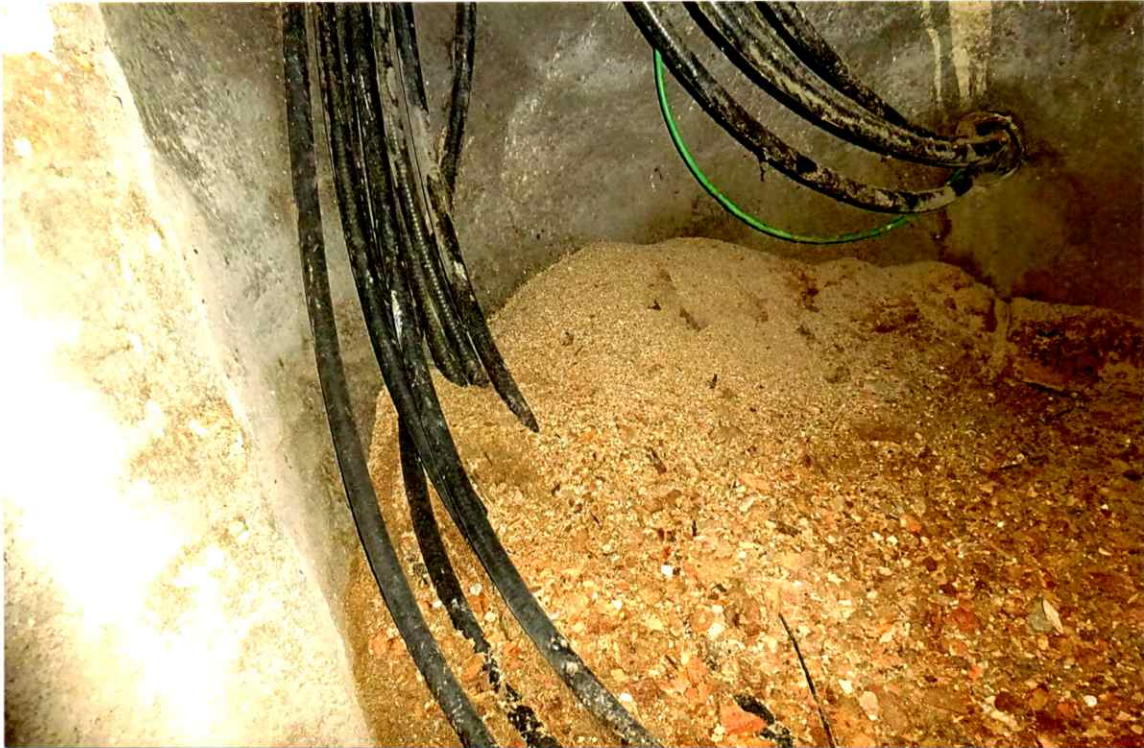
Photo 82. Good interior condition of the guniting tunnel inside the cleanout door.

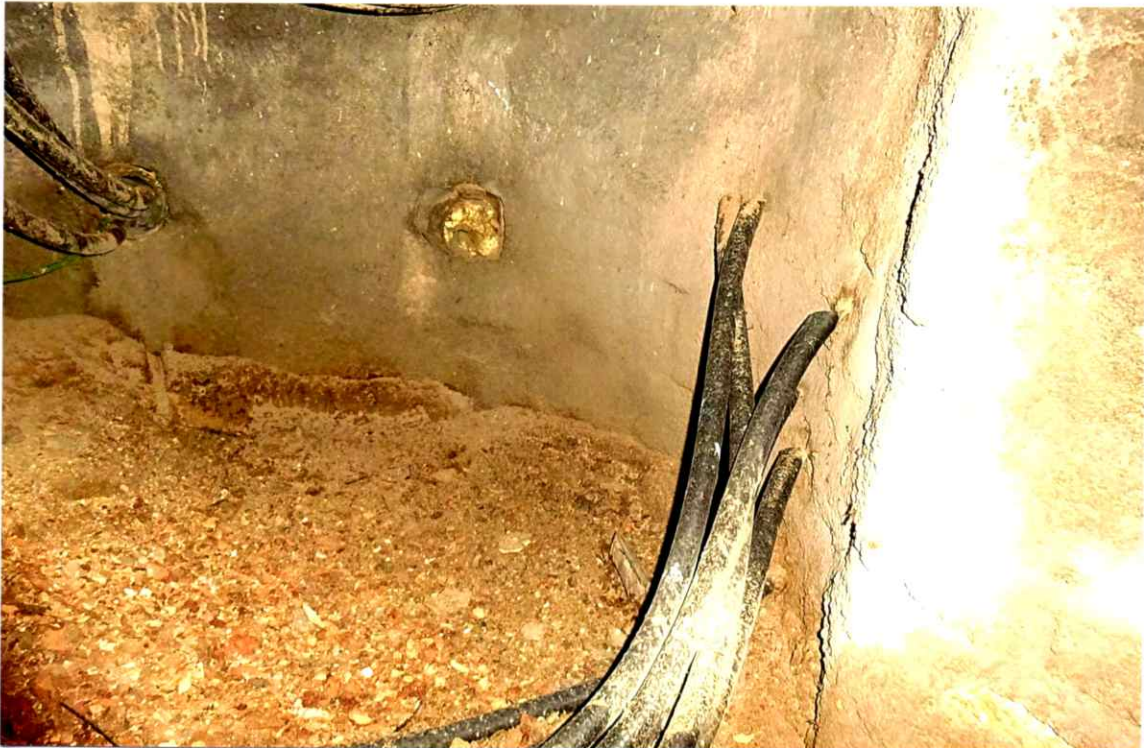
Photo 83. 8" of accumulated debris in the base (south side).
